DTC	B1248	AVC-LAN COMMUNICATION IMPOSSIBLE
------------	--------------	---

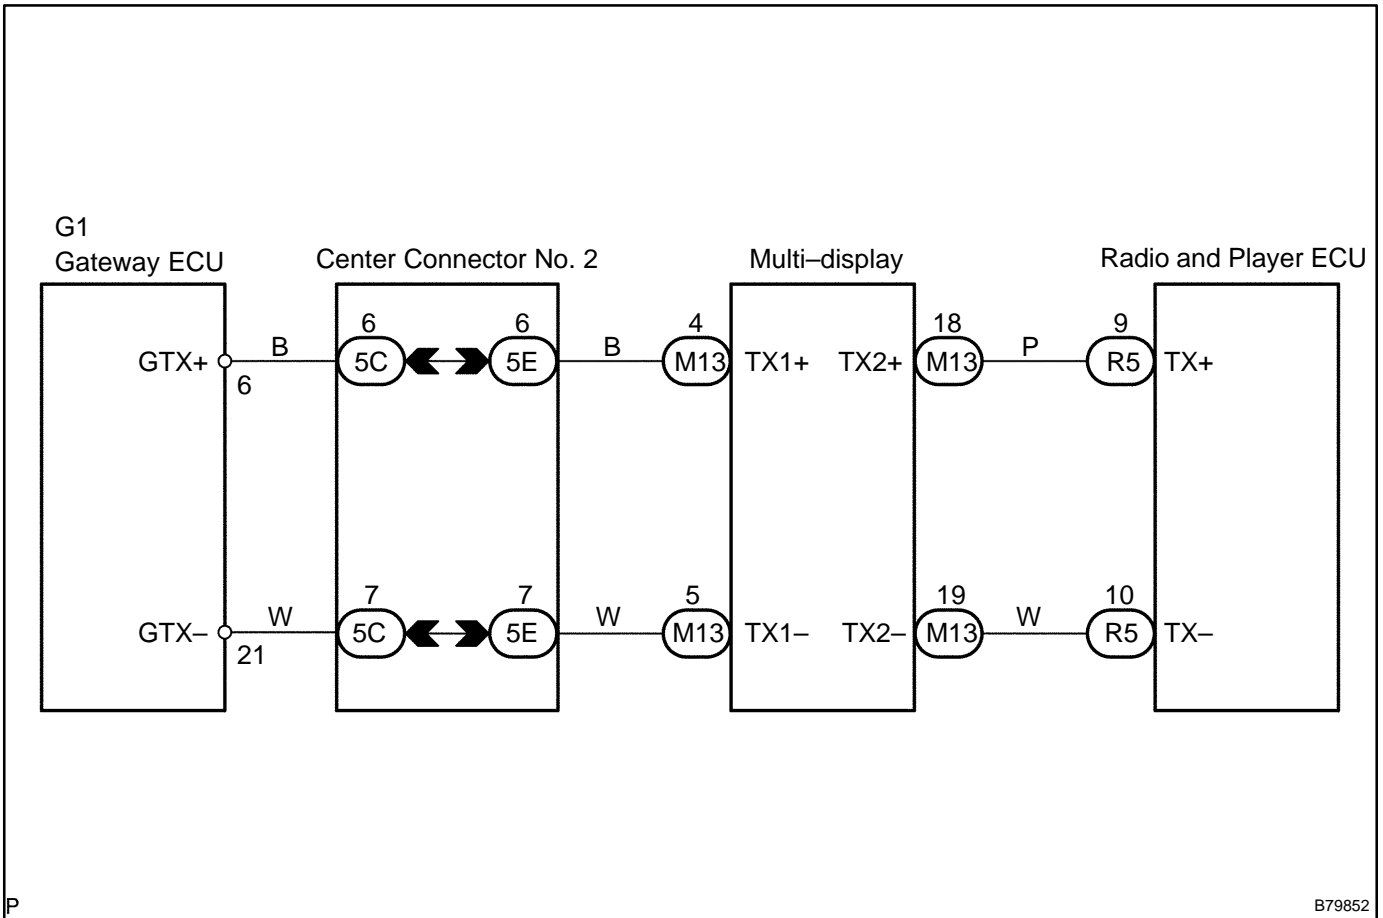
WIRING DIAGRAM

This DTC is detected when communication is impossible between the radio and player ECU and gateway ECU.

DTC No.	DTC Detection Condition	Trouble Area
B1248	AVC-LAN communication is impossible	<ul style="list-style-type: none"> • Radio and player ECU • Wire harness

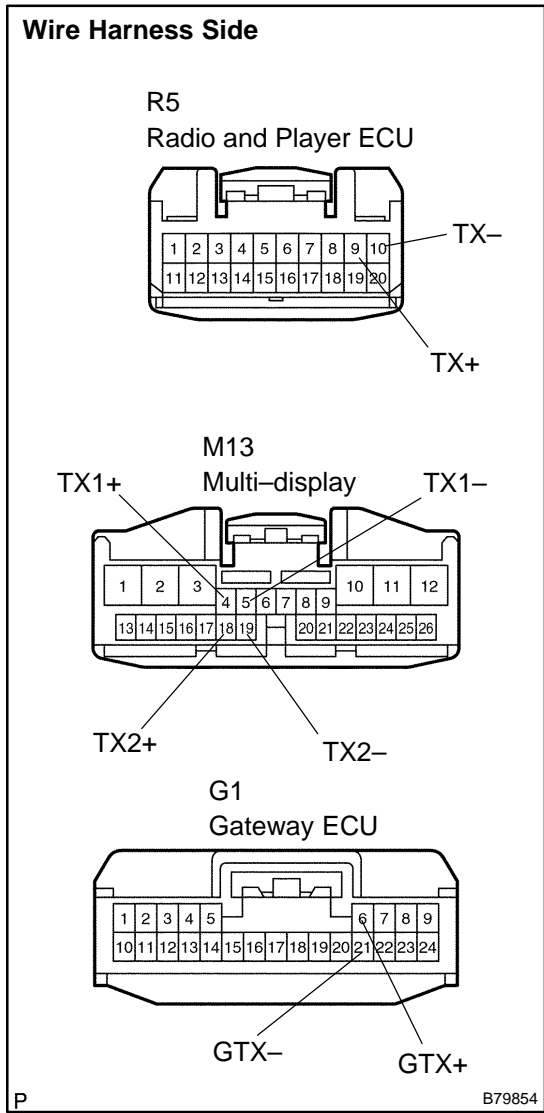
2 CHECK RESISTANCE OF COMMUNICATION LINE

- (a) Disconnect the R5, M13 and G1 ECU connectors.
- (b) Measure the resistance between the wire harness side connectors.

Tester Connection	Specified Condition
R5-9 (TX+) - M13-18 (TX2+)	Below 1 Ω
R5-10 (TX-) - M13-19 (TX2-)	Below 1 Ω
M13-4 (TX1+) - G1-6 (GTX+)	Below 1 Ω
M13-5 (TX1-) - G1-21 (GTX-)	Below 1 Ω

NG **REPAIR OR REPLACE HARNESS AND CONNECTOR**

REPLACE RADIO AND PLAYER ECU
