DTC	B2785	IGNITION SWITCH ON MALFUNCTION
------------	--------------	---------------------------------------

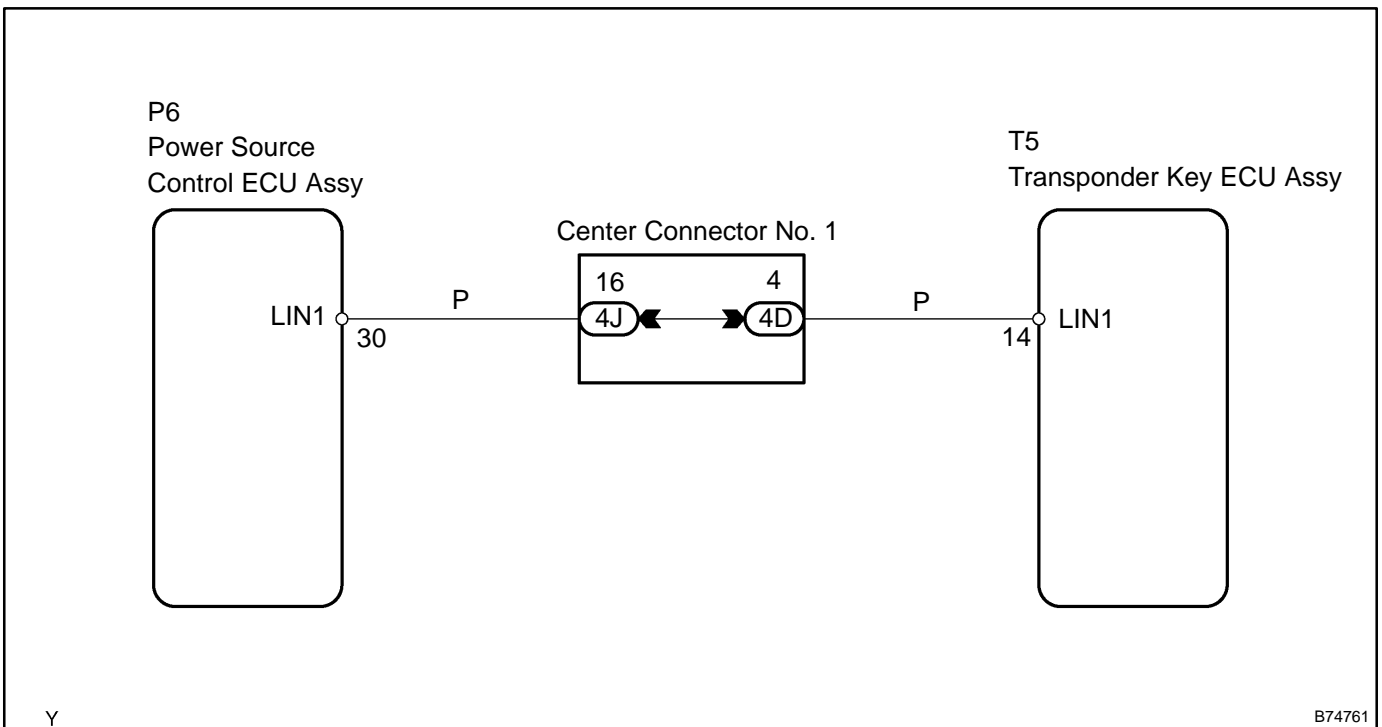
WIRING DIAGRAM

This DTC is output if communication between the transponder key ECU and power source control ECU is not possible.

DTC No.	DTC Detection Condition	Trouble Area
B2785	Communication between the transponder key ECU and power source control ECU is not possible	<ul style="list-style-type: none"> • Wire harness • Power source control ECU assy • Transponder key ECU assy

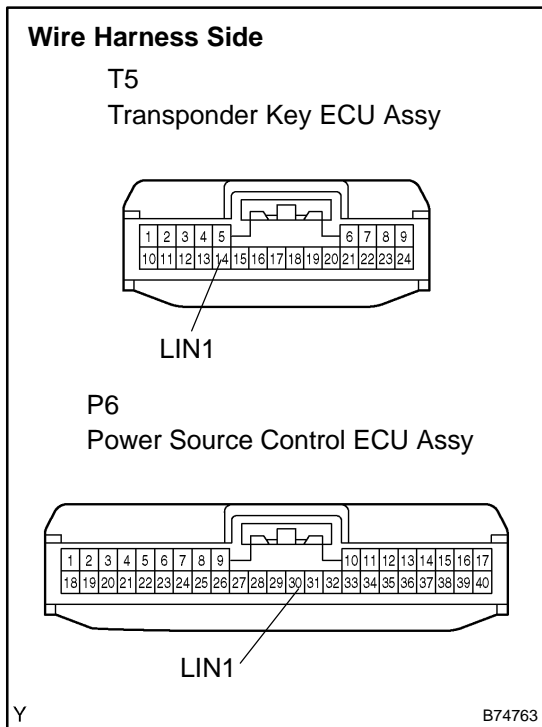
1 CHECK WIRE HARNESS (TRANSPONDER KEY ECU ASSY – POWER SOURCE CONTROL ECU ASSY)

- (a) Reconnect the T5 and P6 ECU connector.
- (b) Measure the resistance of each terminal of the wire harness side connectors.

Tester Connection	Specified Condition
T5-14 (LIN1) – P6-30 (LIN1)	Below 1 Ω
T5-14 (LIN1) or P6-30 (LIN1) – Body ground	10 kΩ or higher

NG → **REPAIR OR REPLACE WIRE HARNESS AND CONNECTOR**
