# RADIO RECEIVER ASSY REPLACEMENT

2004 Prius - Preliminary Release (RM1075U)

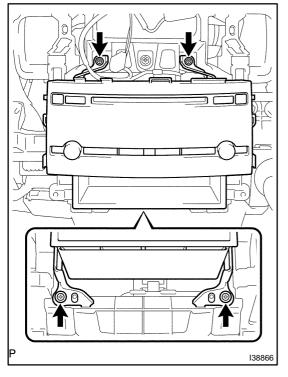
# 5. REMOVE RADIO RECEIVER ASSEMBLY W/BRACKET

- (a) Remove the 4 screws.
- (b) Disconnect the connector and remove the radio receiverassembly w/ bracket.
