DTC	B1200	BODY ECU COMMUNICATION STOP
------------	--------------	------------------------------------

CIRCUIT DESCRIPTION

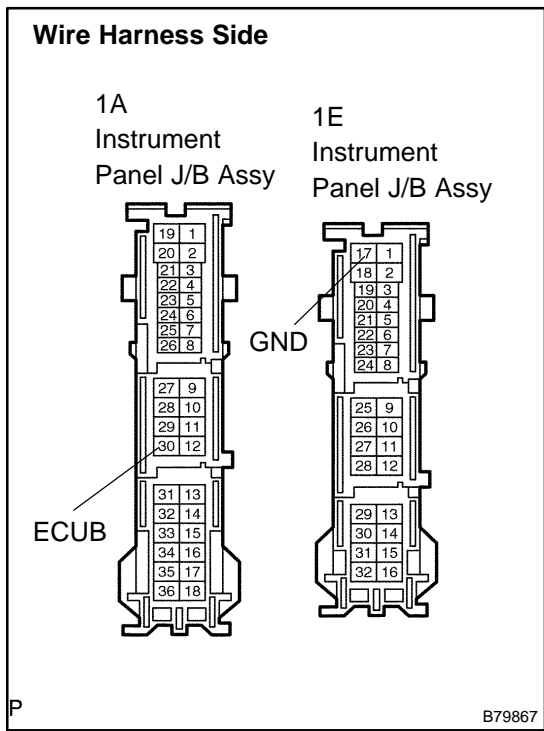
2 CHECK WIRE HARNESS (INSTRUMENT PANEL J/B ASSY - BODY GROUND)

- (a) Disconnect the 1A and 1E J/B connectors.
- (b) Measure the voltage and resistance of the wire harness side connectors.

Tester Connection	Specified Condition
1A-30 (ECUB) - Body ground	10 to 14 V
1E-17 (GND) - Body ground	Below 1 Ω
