DTC	B2797	COMMUNICATION MALFUNCTION NO.1
------------	--------------	---------------------------------------

CIRCUIT DESCRIPTION

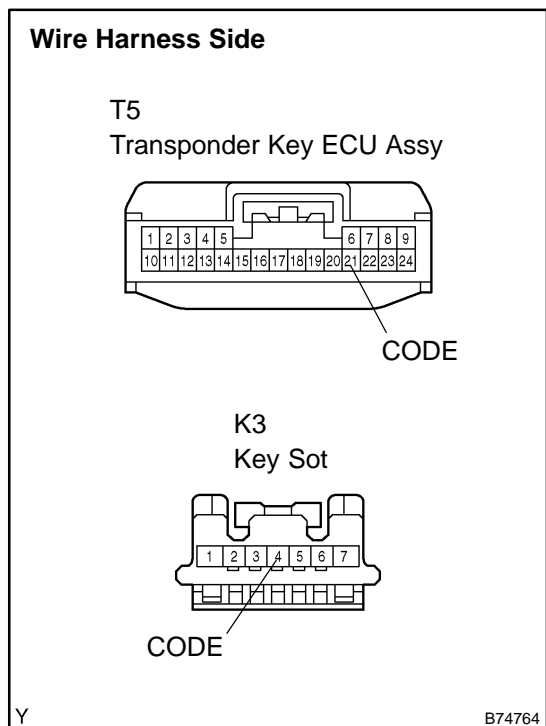
- (a) Disconnect the T5 ECU connector.
- (b) Disconnect the K3 key slot connector.
- (c) Measure the resistance of the wire harness side connectors.

Tester Connection	Specified Condition
T5-21 (CODE) – K3-4 (CODE)	Below 1 Ω
