Cellular Communication

Cellular Communication Component Views

Cellular Communication Sub-System SIO-ID = 808750 LMD = 24-jun-2002

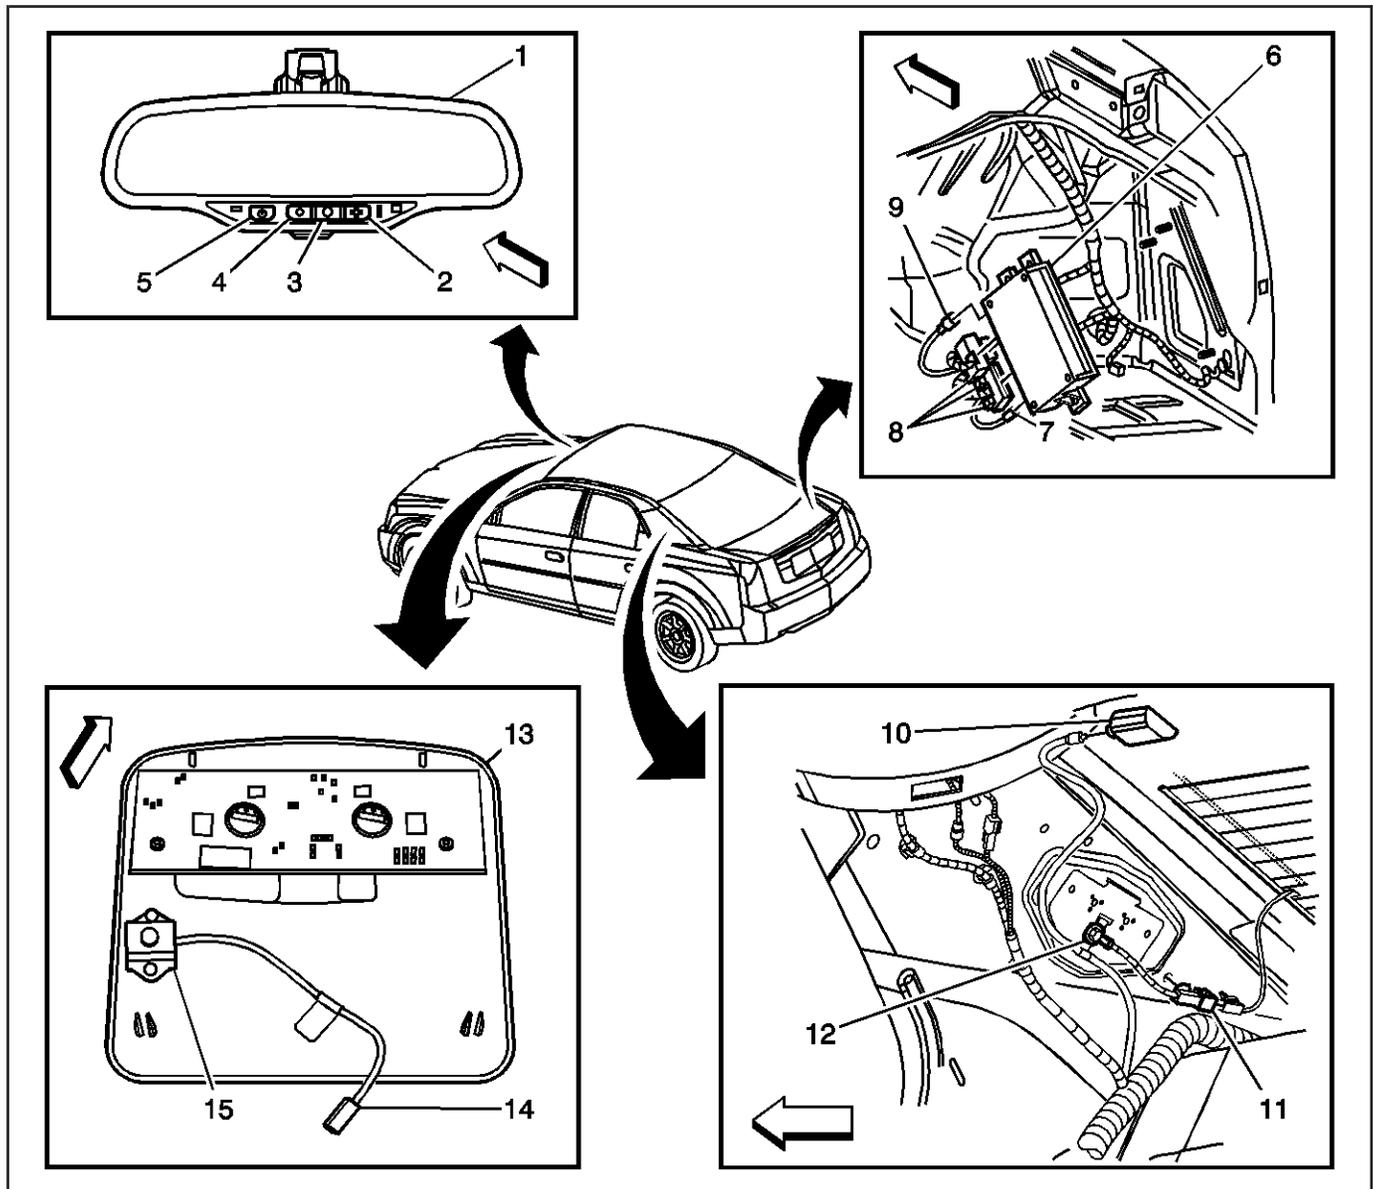
801220

Legend

| (1) Inside Rear View Mirror (ISRVM) | (9) Cellular Antenna |
| (2) Emergency Button | (10) GPS Antenna |
| (3) Onstar Button | (11) Rear Defogger Connector |
| (4) Onstar Answer/End Call Button | (12) G303 |
| (5) Electrochromatic Mirror Button | (13) Overhead Console |
| (6) Vehicle Communication Interface Module (VCIM) | (14) Noise Compensation Microphone Connector |
| (7) GPS Antenna Connector | (15) Noise Compensation Microphone |
| (8) Vehicle Communication Interface Module Connectors | |

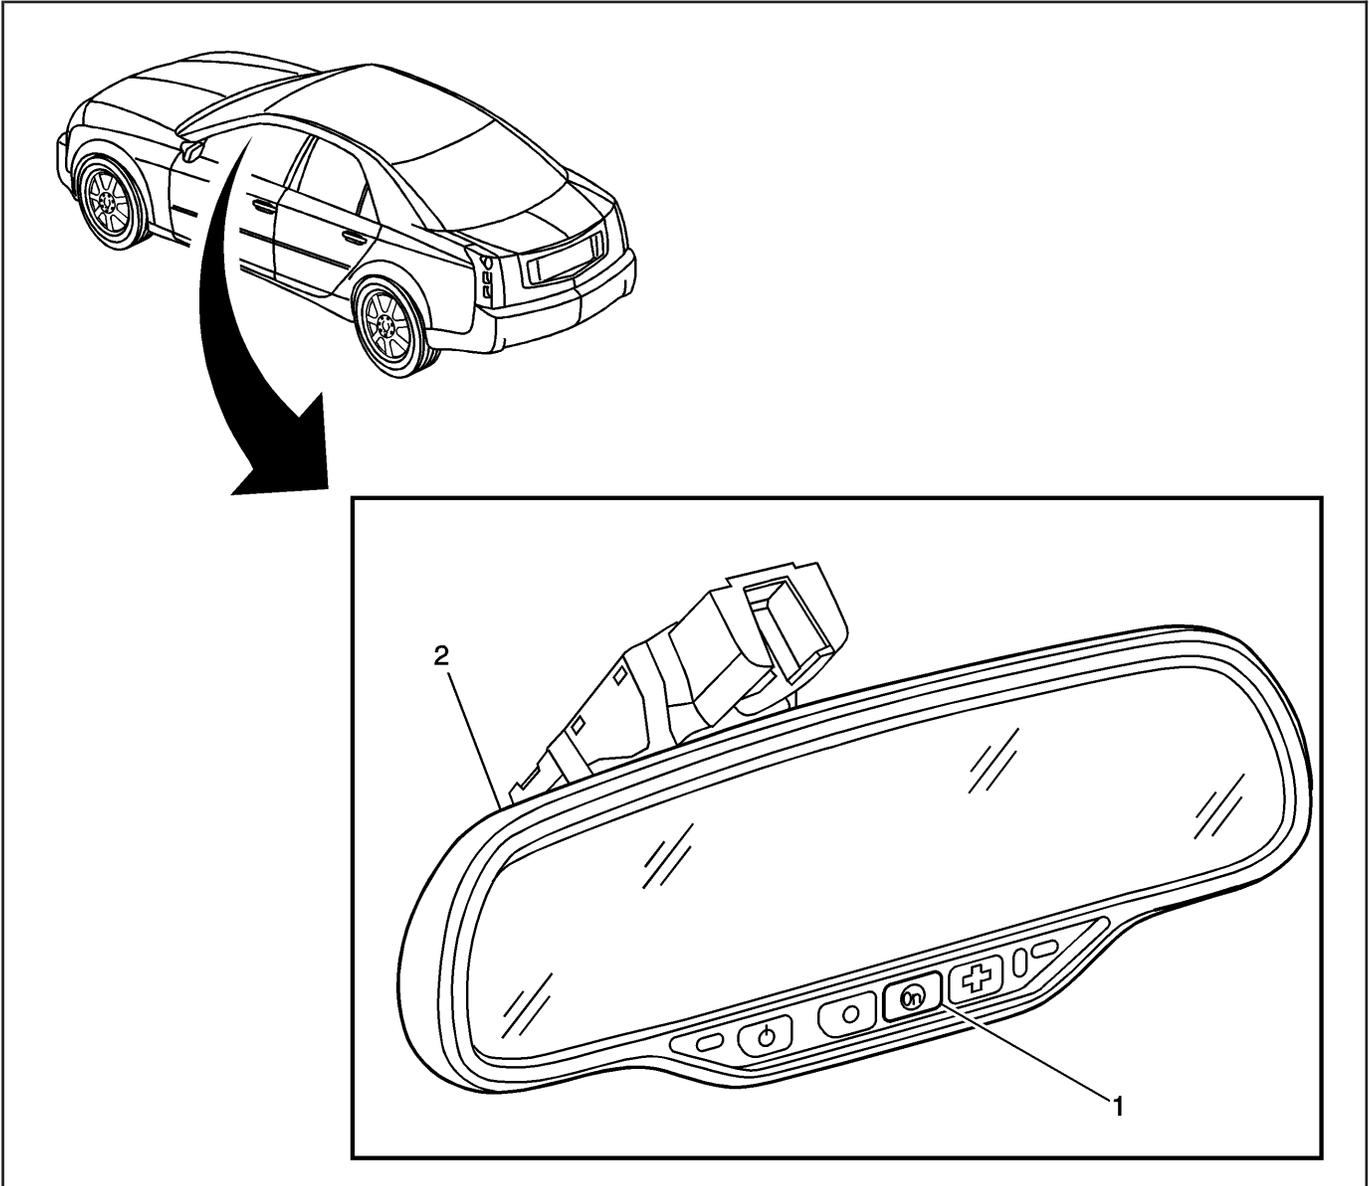
1348817

OnStar Keypad SIO-ID = 1364257 LMD = 05-aug-2003

(2) Inside Rearview Mirror (ISRVM)

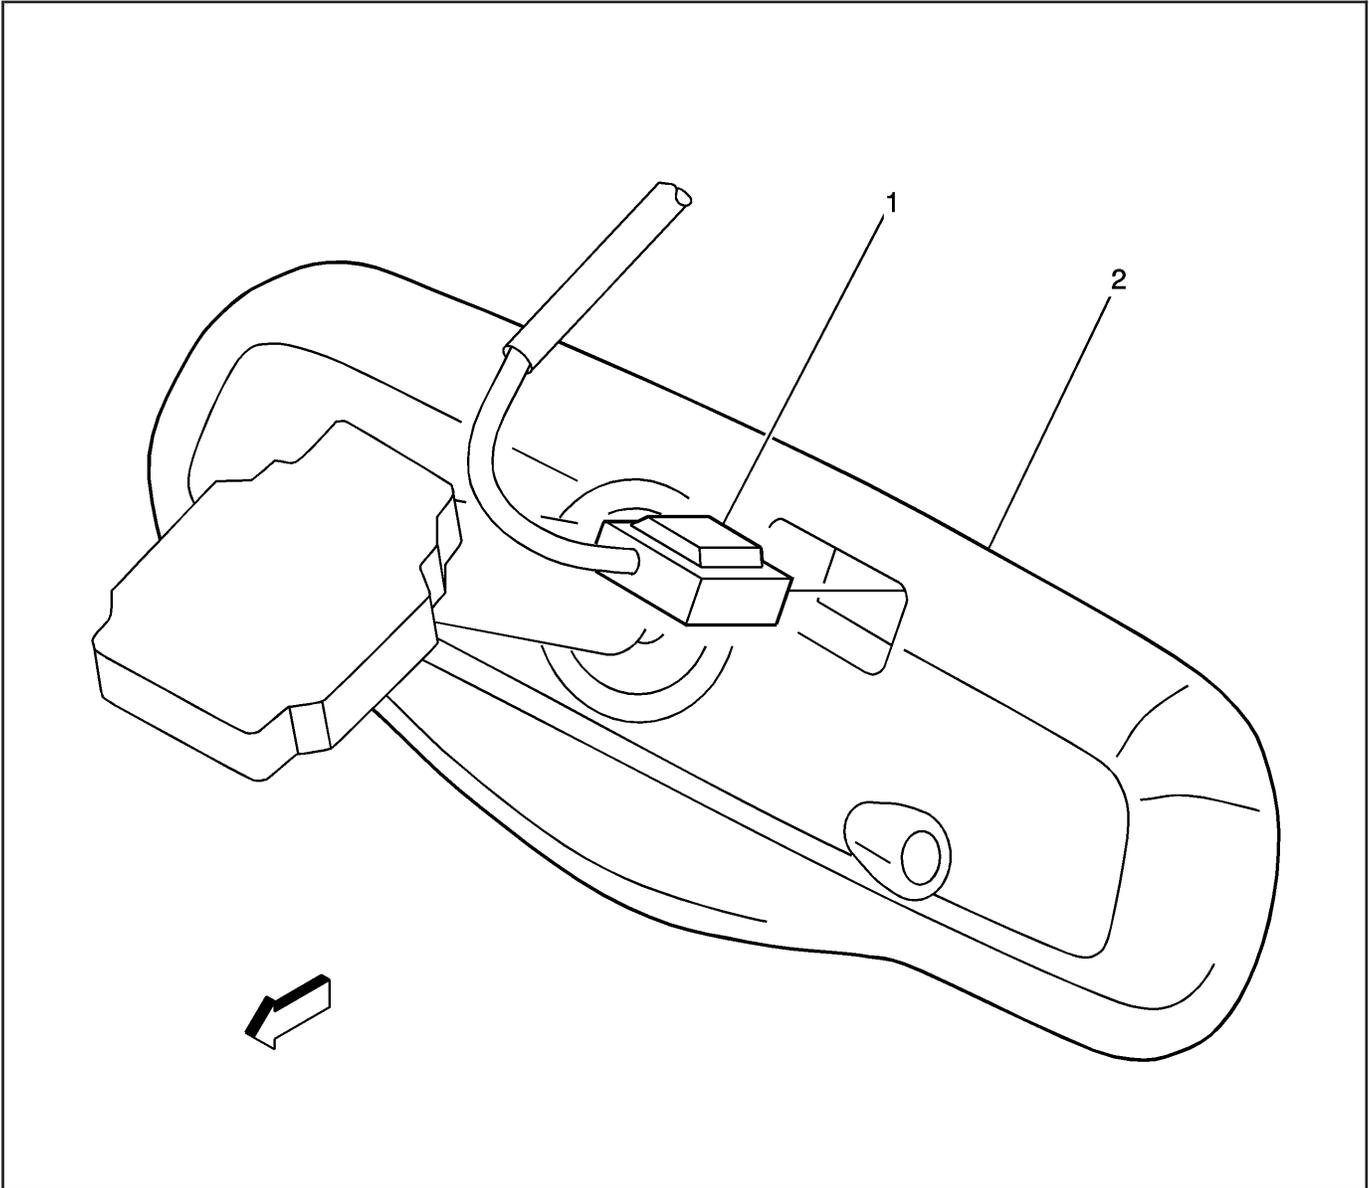
1348815

Inside Rearview Mirror (ISRV) SIO-ID = 1364183 LMD = 05-aug-2003

(2) Inside Rearview Mirror (ISRV)

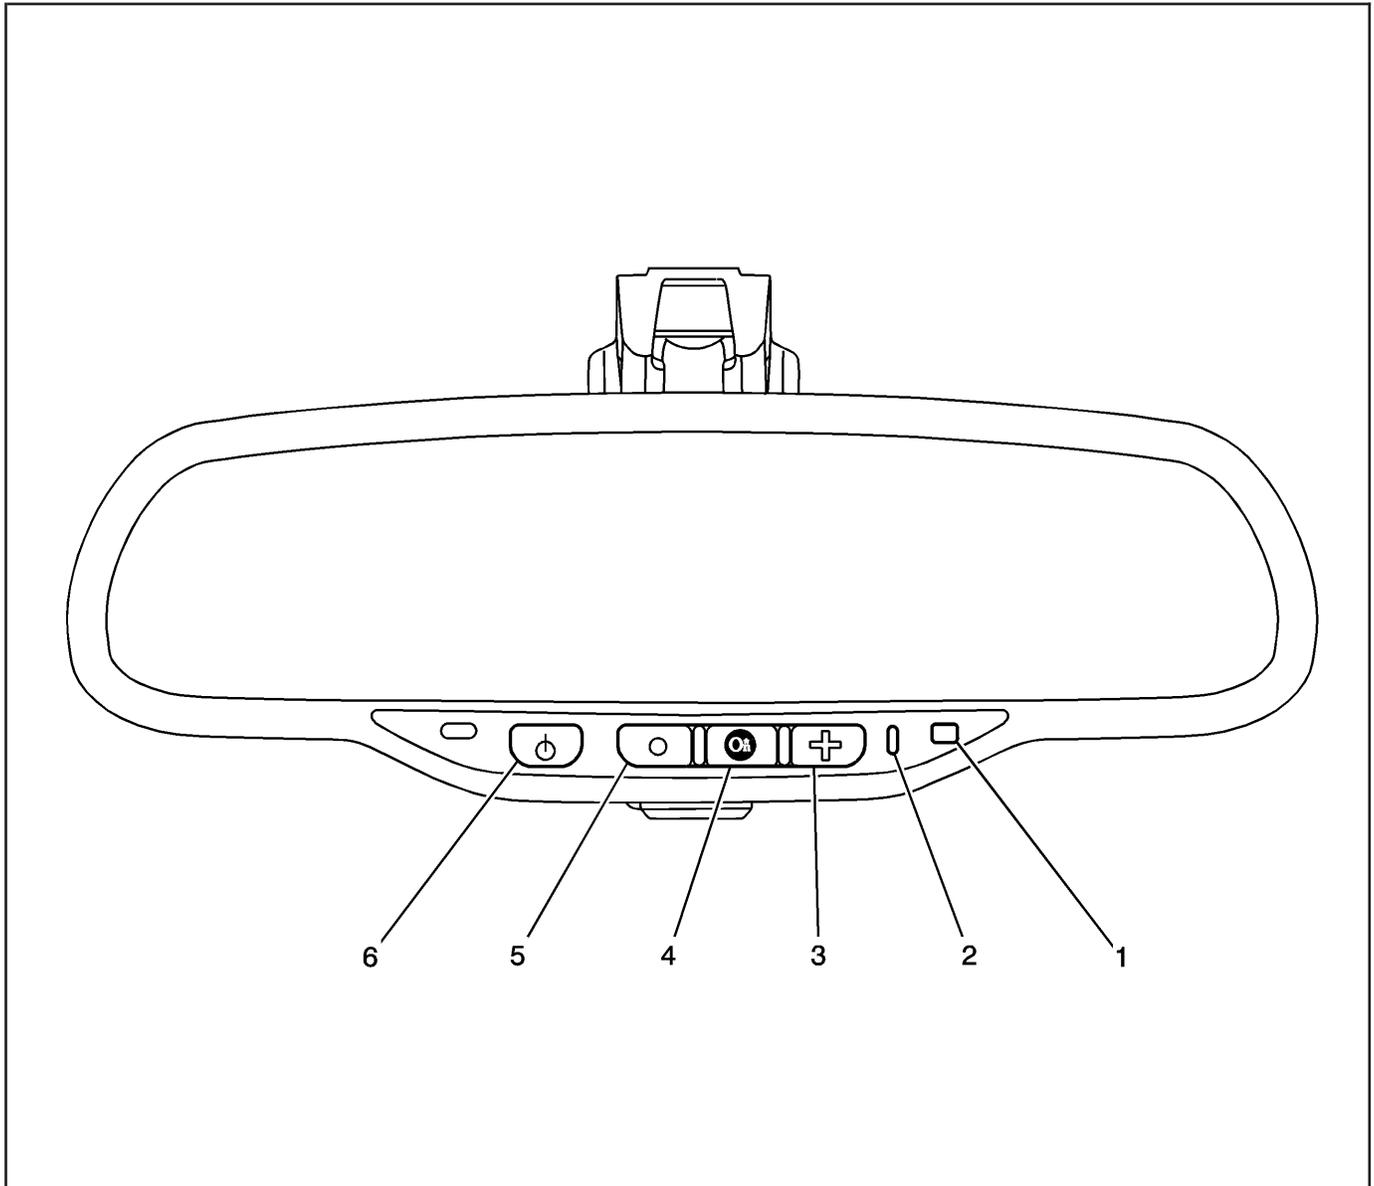
1348819

OnStar Keypad Identification SIO-ID = 1364259 LMD = 05-aug-2003

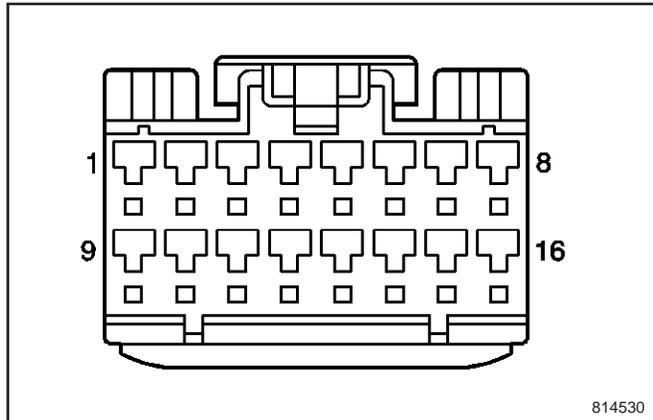
**Vehicle Communication Interface
Module (VCIM) C1 (UE1)**

Connector Part Information		<ul style="list-style-type: none"> • 917981-1 • 16-Way F MKII Hybrid (WH) 	
Pin	Wire Color	Circuit Number	Function
1	—	—	Not Used
2	PU	1156	Keypad Red LED Signal
3	GY/BK	1798	Keypad Green LED Signal
4-5	—	—	Not Used
6	BN	1941	Keypad Supply Voltage
7	BK/WH	851	Ground
8-10	—	—	Not Used
11	PU	679	Keypad Signal
12-14	—	—	Not Used
15	RD/WH	2240	Battery Positive Voltage
16	—	—	Not Used

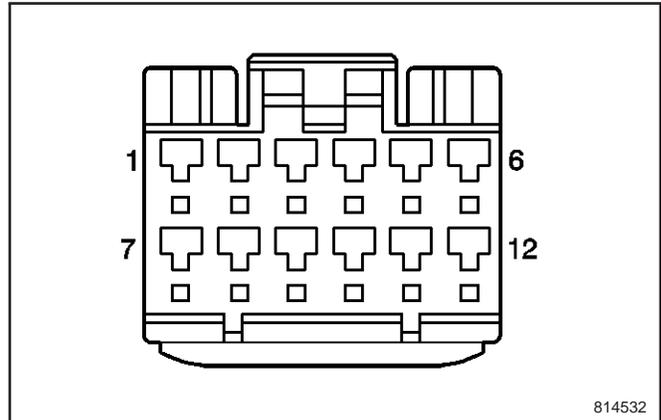
**Vehicle Communication Interface
Module (VCIM) C2 (UE1)**

Connector Part Information		<ul style="list-style-type: none"> • 917975-1 • 12-Way F MKII Hybrid (WH) 	
Pin	Wire Color	Circuit Number	Function
1	D-BU	658	Cellular Telephone Voice Signal
2	L-BU/BK	659	Cellular Telephone Voice Low Reference
3-5	—	—	Not Used
6	PU	1807	Class 2 Serial Data
7	—	—	Not Used
8	BARE	814	Drain Wire
9	GY	655	Cellular Microphone Signal
10	BARE	1782	Drain Wire
11-12	—	—	Not Used

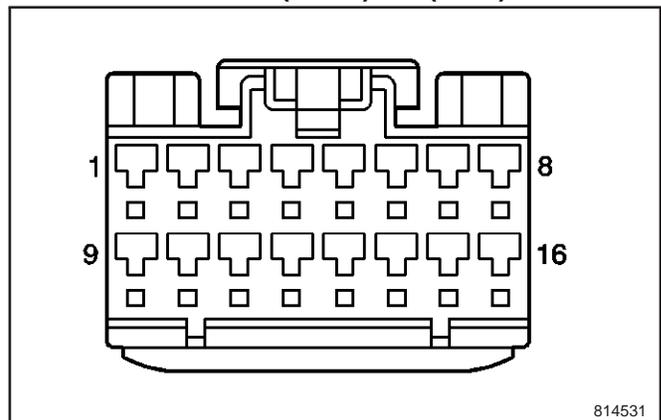
**Vehicle Communication Interface
Module (VCIM) C3 (UAV)**

Connector Part Information		<ul style="list-style-type: none"> • 917983-2 • 16-Way F MKII Hybrid (BK) 	
Pin	Wire Color	Circuit Number	Function
1	D-GN	5142	Modem TX (Not Used)
2	PK	5149	Cellular Microphone Signal
3	L-BU	5141	Modem RX (Not Used)

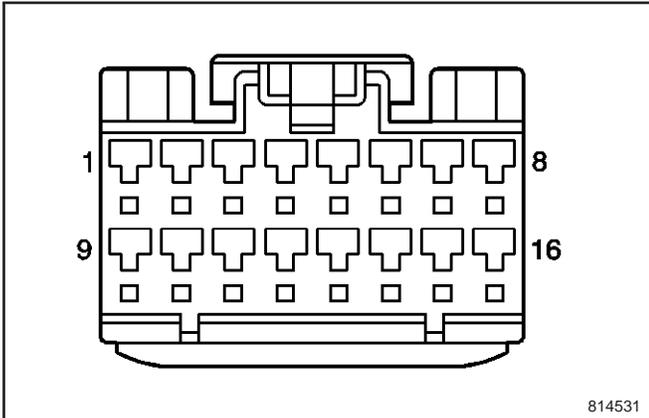
814531

**Vehicle Communication Interface
Module (VCIM) C3 (UAV) (cont'd)**

Connector Part Information		<ul style="list-style-type: none"> • 917983-2 • 16-Way F MKII Hybrid (BK) 	
Pin	Wire Color	Circuit Number	Function
4	PK/BK	5152	Cellular Microphone Low Reference
5	BARE	1792	Drain Wire
6-8	—	—	Not Used
9	YE/BK	5143	Modem Ground (Not Used)
10	BARE	701	Drain Wire
11-16	—	—	Not Used

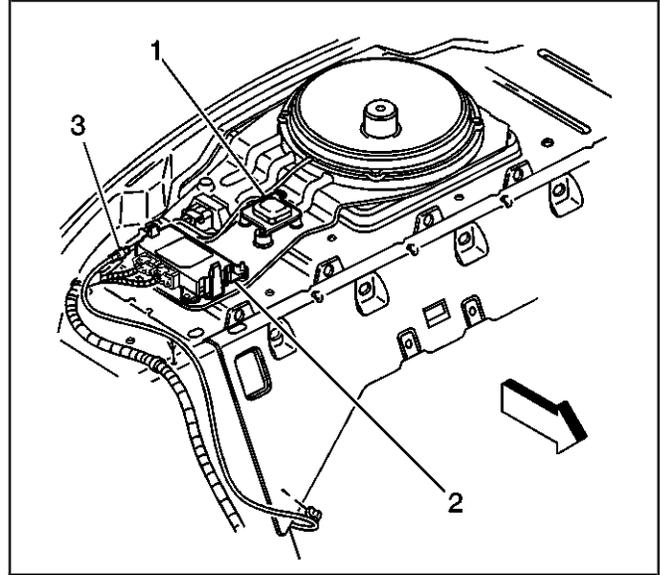
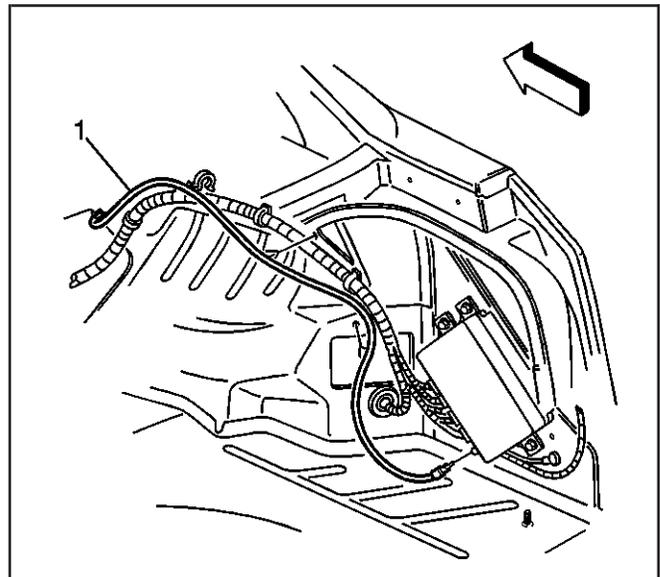
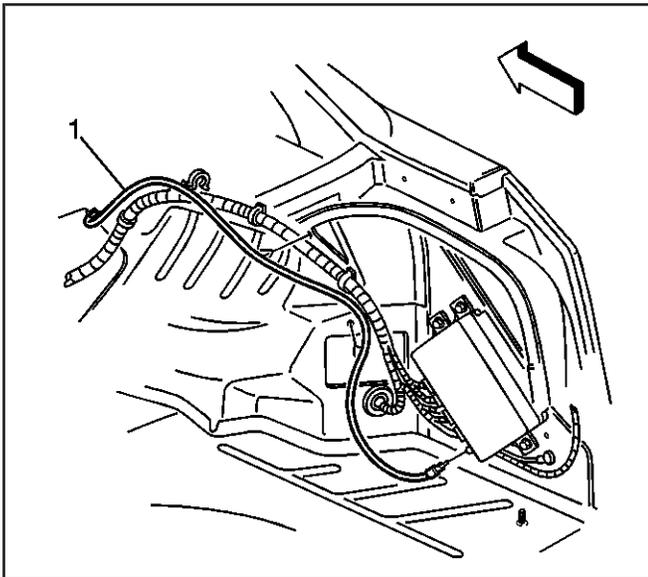
1. Remove the rear compartment trim. Refer to *Compartment Trim Panel Replacement - Rear* on page 8-14 in Body Rear End.
2. Remove the rear shelf trim cover. Refer to *Trim Panel Replacement - Rear Window Shelf* on page 8-33 in Interior Trim.
3. Disconnect the GPS antenna coax cable (3).
4. Disconnect the coax cable (1) at the interface module.
5. Pull the cable (1) through to the rear compartment.

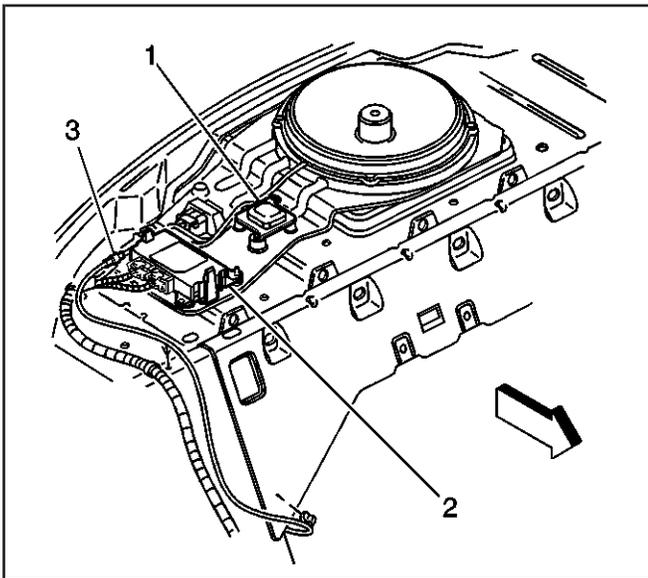
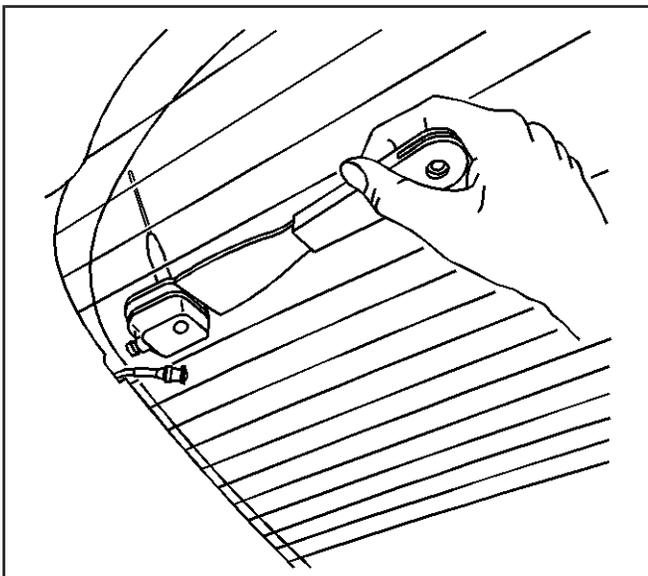
1. Connect the cable (1) to the interface module.
2. Push the cable (1) through the rear compartment to the passenger compartment.

3. Connect the cable (3) the GPS antenna.
4. Install the rear shelf trim cover. Refer to *Trim Panel Replacement - Rear Window Shelf* on page 8-33 in Interior Trim.
5. Install the rear compartment trim. Refer to *Compartment Trim Panel Replacement - Rear* on page 8-14 in Body Rear End.

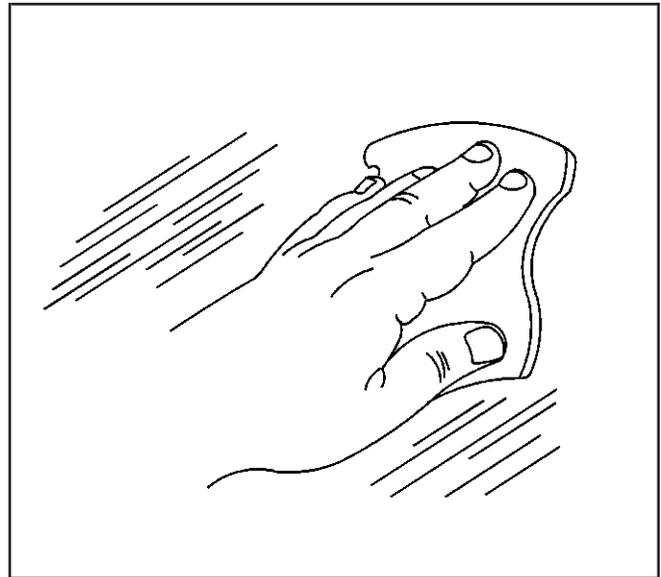
569466

- The adhesion promoter must be used to assure adequate bonding of the coupling.
 - Mask off or protect areas before applying the adhesion promoter.
3. Apply Glass Adhesion Promoter GM P/N 12378555 (Canadian P/N 88901239) to the rear window in the area where you will install the antenna coupling. Follow the Glass Adhesion Promoter instructions on the product label.

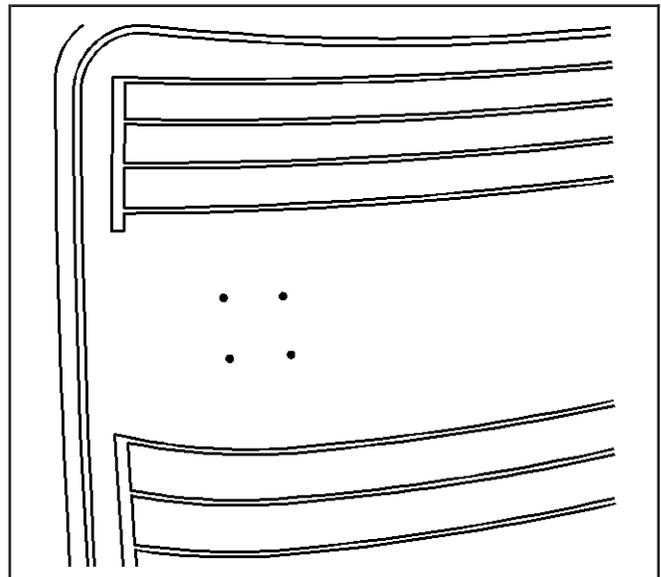
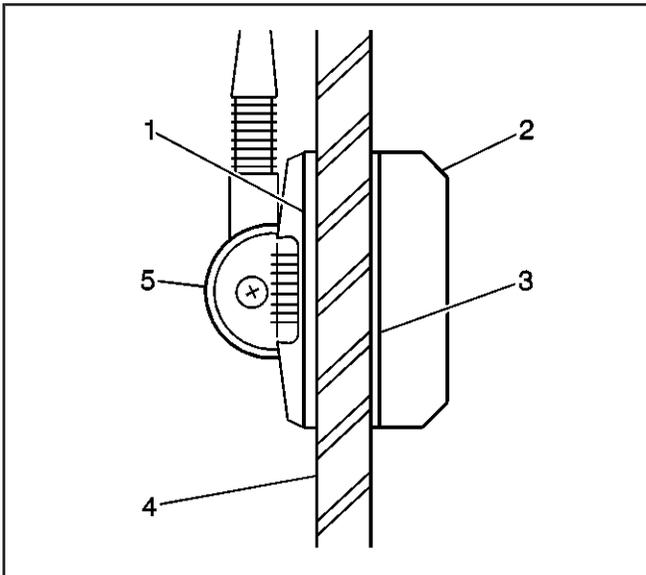
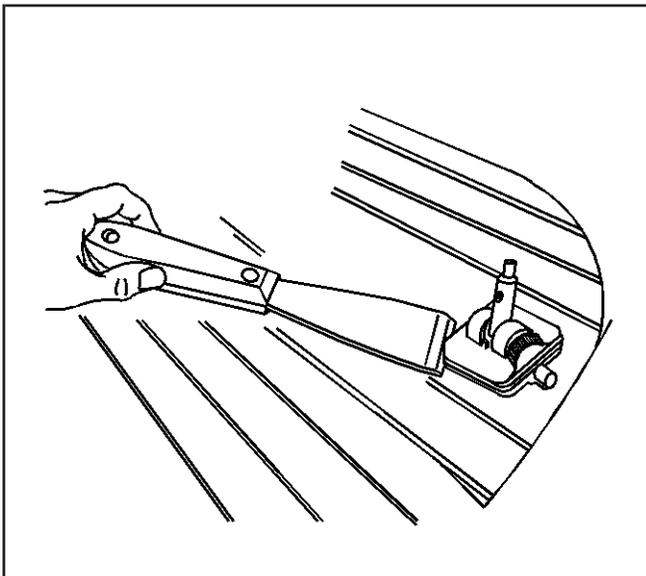
- The RF connections for the inner antenna coupling should run parallel to the defogger gridline.
 - Align the inner and the outer antenna couplings.
 - Do not touch the adhesive backing on the antenna coupling.
4. Remove the protective film from the adhesive backing on the inner antenna coupling.
 5. Align the inner antenna coupling either to the 4 locating marks on the rear window above the defogger gridline, or to the existing exterior coupling.

6. Press firmly on all 4 corners and on the center of the antenna inner coupling (2) in order to ensure proper adhesion to the rear window (4). Hold pressure on the inner coupling (2) for 10–30 seconds.
7. Ensure that no gaps occur between the couplings (2,5) and the rear window (4).
8. Connect the coaxial cable to the inner coupling (2).
9. Keep the vehicle dry. Allow 6 to 8 hours, at 15°C (60°F), for the adhesive to cure after installation.

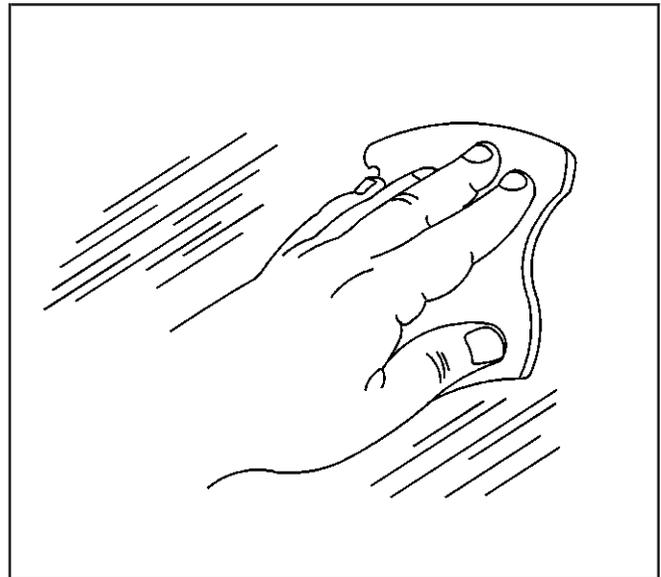
569466

- The adhesion promoter must be used to assure adequate bonding of the coupling.
 - Mask off or protect areas before applying the adhesion promoter.
3. Apply Glass Adhesion Promoter GM P/N 12378555 (Canadian P/N 88901239) to the rear window in the area where you will install the antenna coupling. Follow the Glass Adhesion Promoter instructions on the product label.

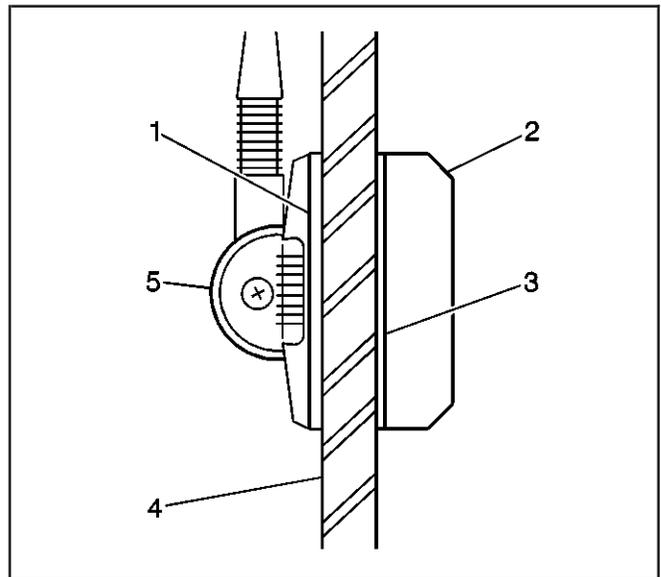
650826

- Align the inner and the outer antenna couplings.
 - Do not touch the adhesive backing on the antenna coupling.
4. Remove the protective film from the adhesive backing on the outer antenna coupling.
 5. Align the outer antenna coupling to the inner antenna coupling.
 6. Press firmly on all 4 corners and on the center of the antenna outer coupling (5) in order to ensure proper adhesion to the rear window (4). Hold pressure on the outer coupling (5) for 10–30 seconds.
 7. Ensure that no gaps occur between the couplings (5, 2) and the rear window (4).
 8. Keep the vehicle dry. Allow 6 to 8 hours, at 15°C (60°F), for the adhesive to cure after installation.

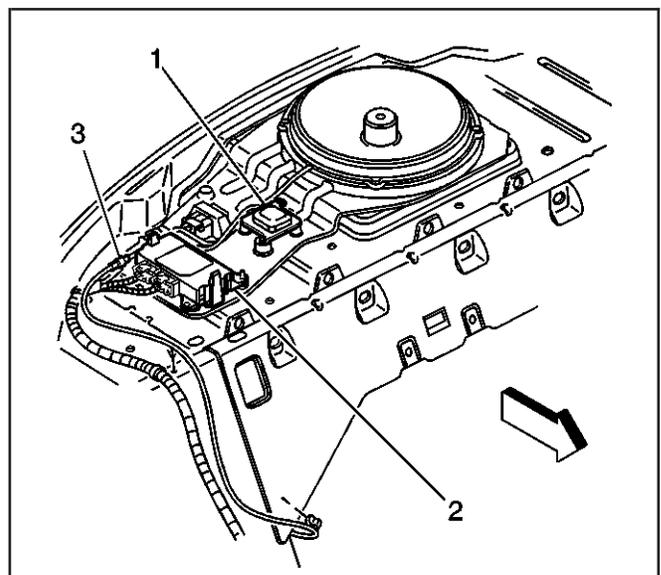
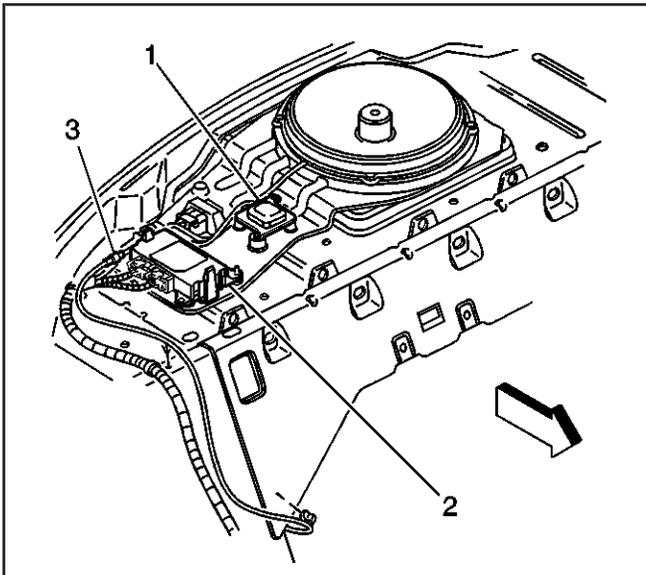
1. Remove the rear shelf trim cover. Refer to *Trim Panel Replacement - Rear Window Shelf* on page 8-33 in Interior Trim.
2. Remove the screws securing the GPS antenna (1) to the electrical carrier.
3. Disconnect the GPS antenna harness (3) at the electrical carrier.

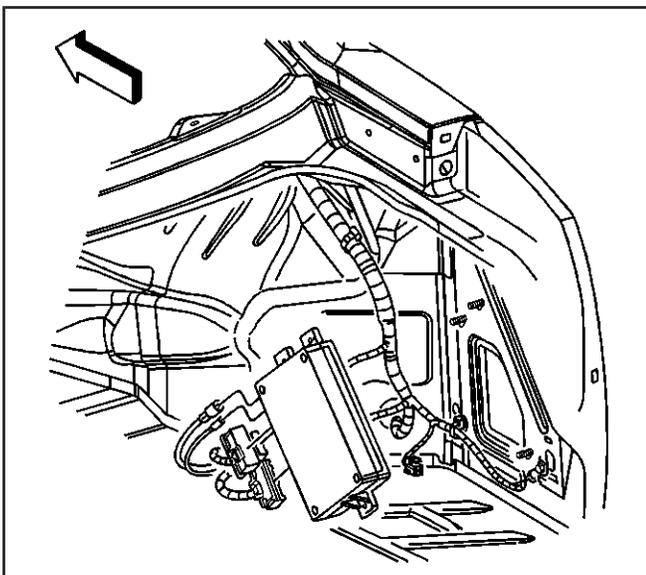
699207

1. Remove the right rear compartment trim. Refer to *Compartment Trim Panel Replacement - Rear* on page 8-14 in Body Rear End.
2. Remove the nuts (2) securing the OnStar® module (1) to the vehicle body.
3. Disconnect all the electrical connectors from the module.
4. Remove the module from the vehicle.

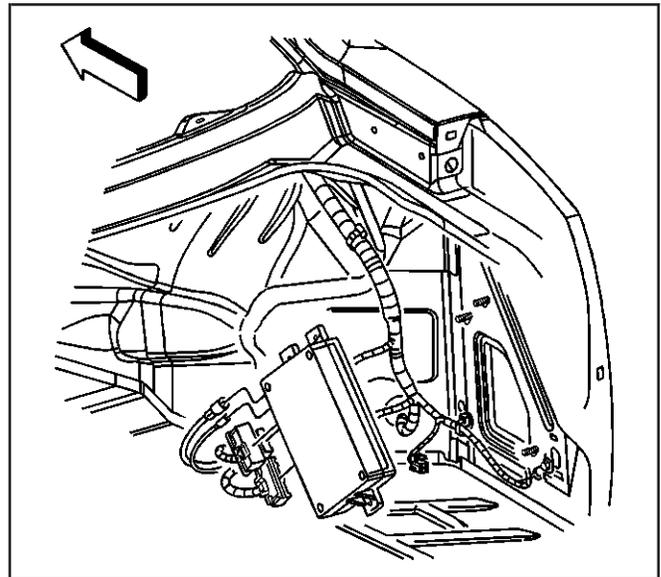
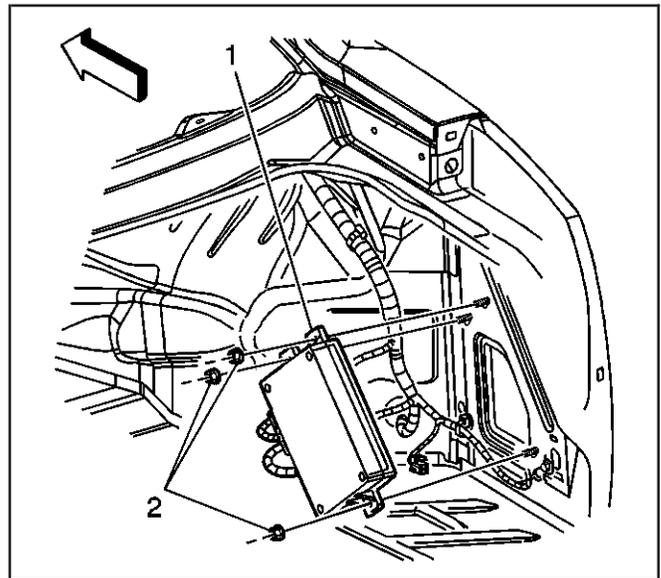
1. When replacing the VCIM, record the 11-digit electronic serial number (ESN) and the 10-digit station identification (STID) number from the label on the new VCIM.
2. Reconnect the electrical connectors the module.

4. Reconfigure the OnStar® system. Refer to *OnStar Reconfiguration* on page 11-33.
