DTC	P3108/535	LOST COMMUNICATION WITH A/C SYSTEM CONTROL MODULE
------------	------------------	--

CIRCUIT DESCRIPTION

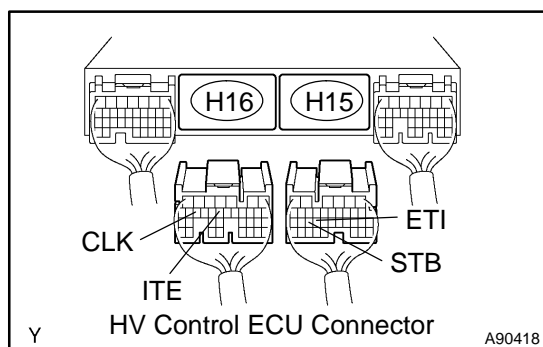
1	CHECK HARNESS AND CONNECTOR(HYBRID VEHICLE CONTROL ECU – A/C INVERTER)
----------	---

- (a) Disconnect the H15 and H16 HV control ECU connectors.
- (b) Disconnect the I11 A/C inverter connector.
- (c) Turn the power switch ON (IG).
- (d) Measure the voltage between the terminals of the HV control ECU connector and body ground.

Tester Connection	Specified Condition
CLK (H16-17) – Body ground	Below 1 V
ITE (H16-14) – Body ground	Below 1 V
ETI (H15-24) – Body ground	Below 1 V
STB (H15-25) – Body ground	Below 1 V

- (e) Turn the power switch OFF.
- (f) Check the resistance between the wire harness side connectors.

Tester Connection	Specified Condition
CLK (H16-17) – CLK (I11-4)	Below 1 Ω
ITE (H16-14) – TOECU (I11-2)	Below 1 Ω
ETI (H15-24) – TOINV (I11-3)	Below 1 Ω
STB (H15-25) – STB (I11-5)	Below 1 Ω

Tester Connection	Specified Condition
CLK (H16-17) or CLK (I11-4) – Body ground	10 k Ω or higher
ITE (H16-14) or TOECU (I11-2) – Body ground	10 k Ω or higher
ETI (H15-24) or TOINV (I11-3) – Body ground	10 k Ω or higher
STB (H15-25) or STB (I11-5) – Body ground	10 k Ω or higher
