DTC	SHORT IN P/T SQUIB (D SEAT SIDE) CIRCUIT

2004 Prius - Preliminary Release (RM1075U)

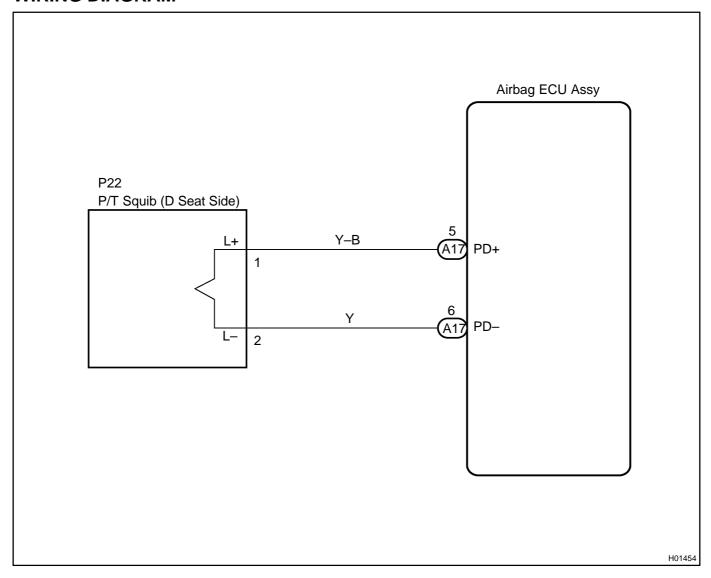
WIRING DIAGRAM

The P/T squib (D seat side) circuit consists of the airbag ECU assy and the front seat outer belt assy LH. This circuit instructs the SRS to deploy when deployment conditions are met.
