SPEAKER CIRCUIT

CIRCUIT DESCRIPTION

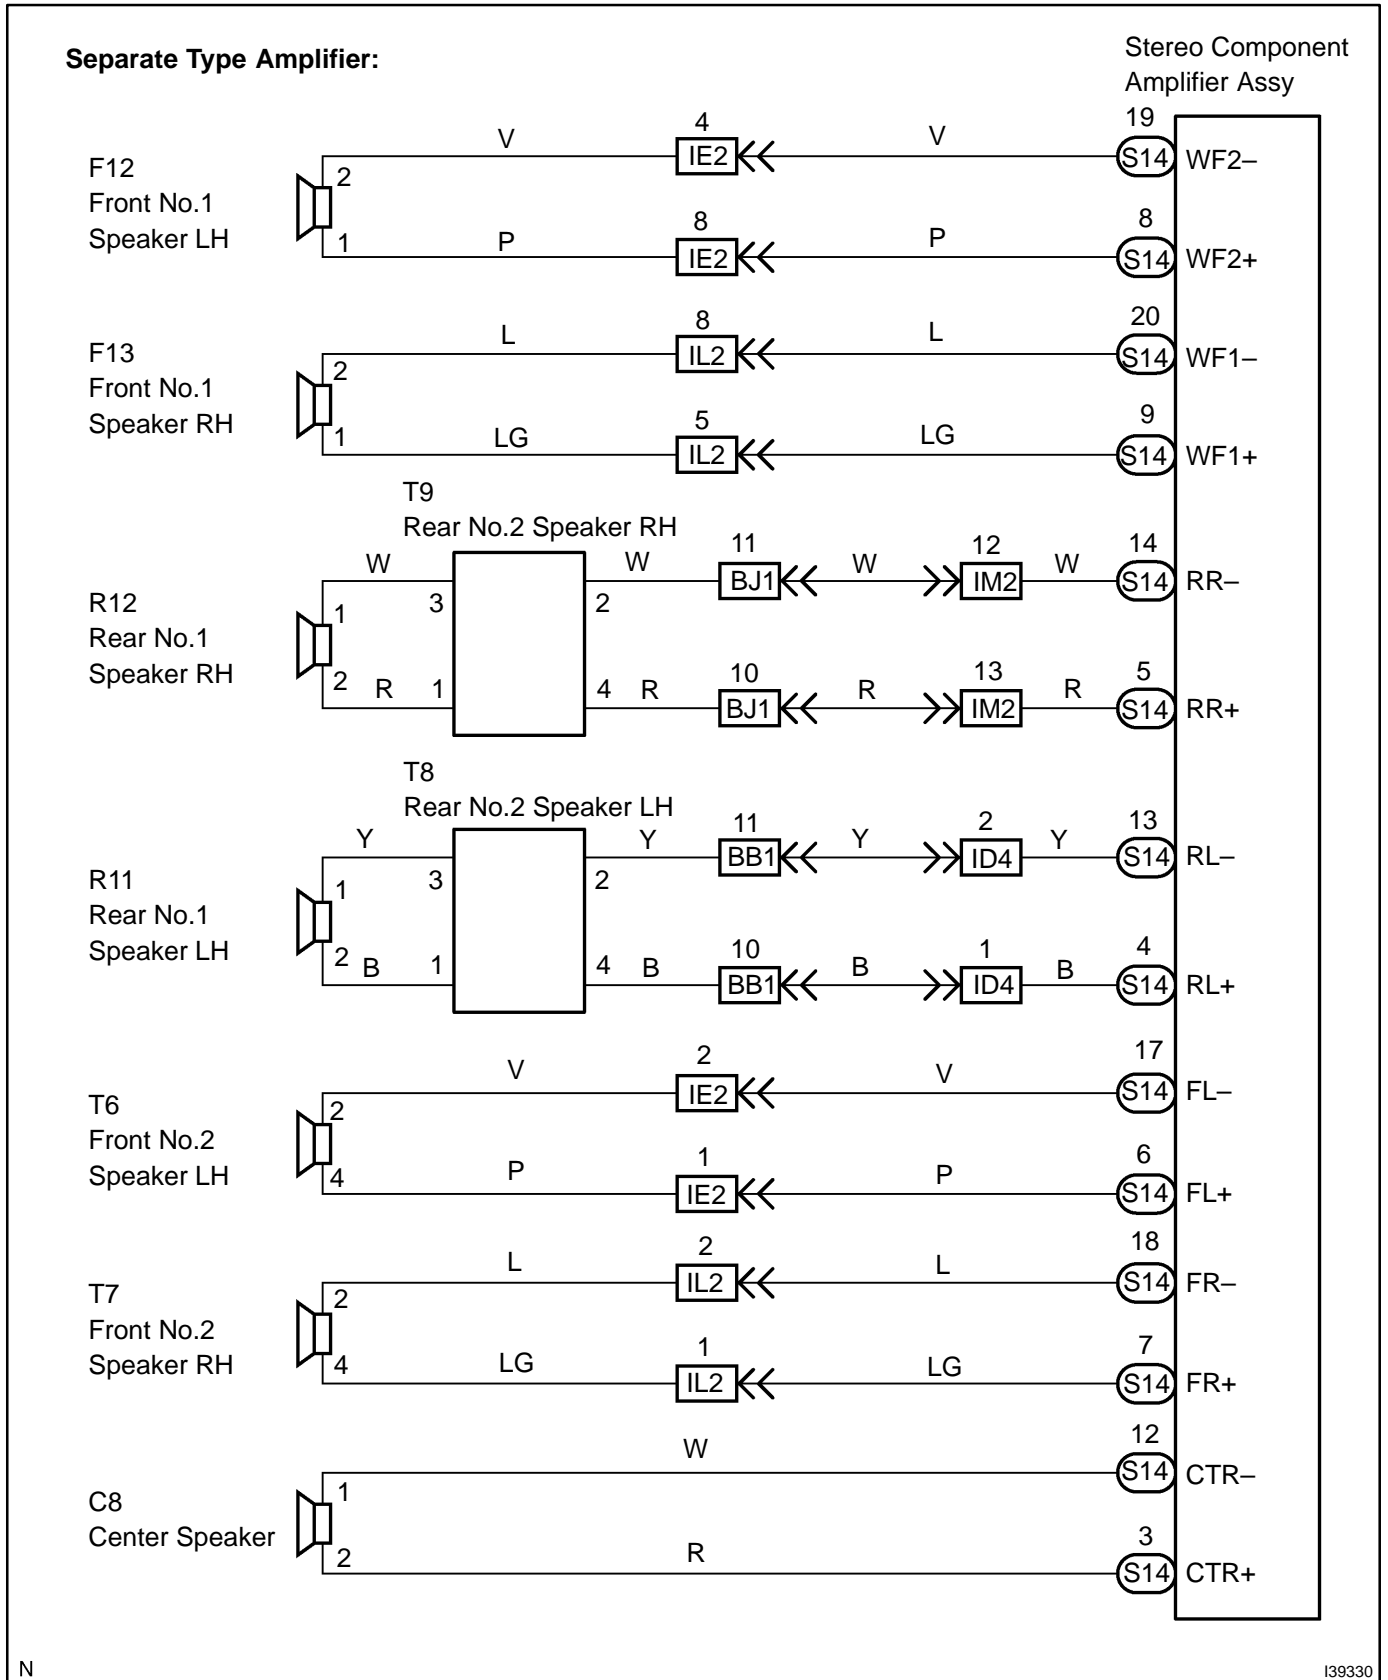
I39330

The sound signal that has been amplified by the stereo component amplifier is sent to the speaker from the stereo component amplifier through this circuit.

As for the vehicle with a navigation system, the sound signal on the driver's side is sent to the navigation ECU from the stereo component amplifier.

WIRING DIAGRAM

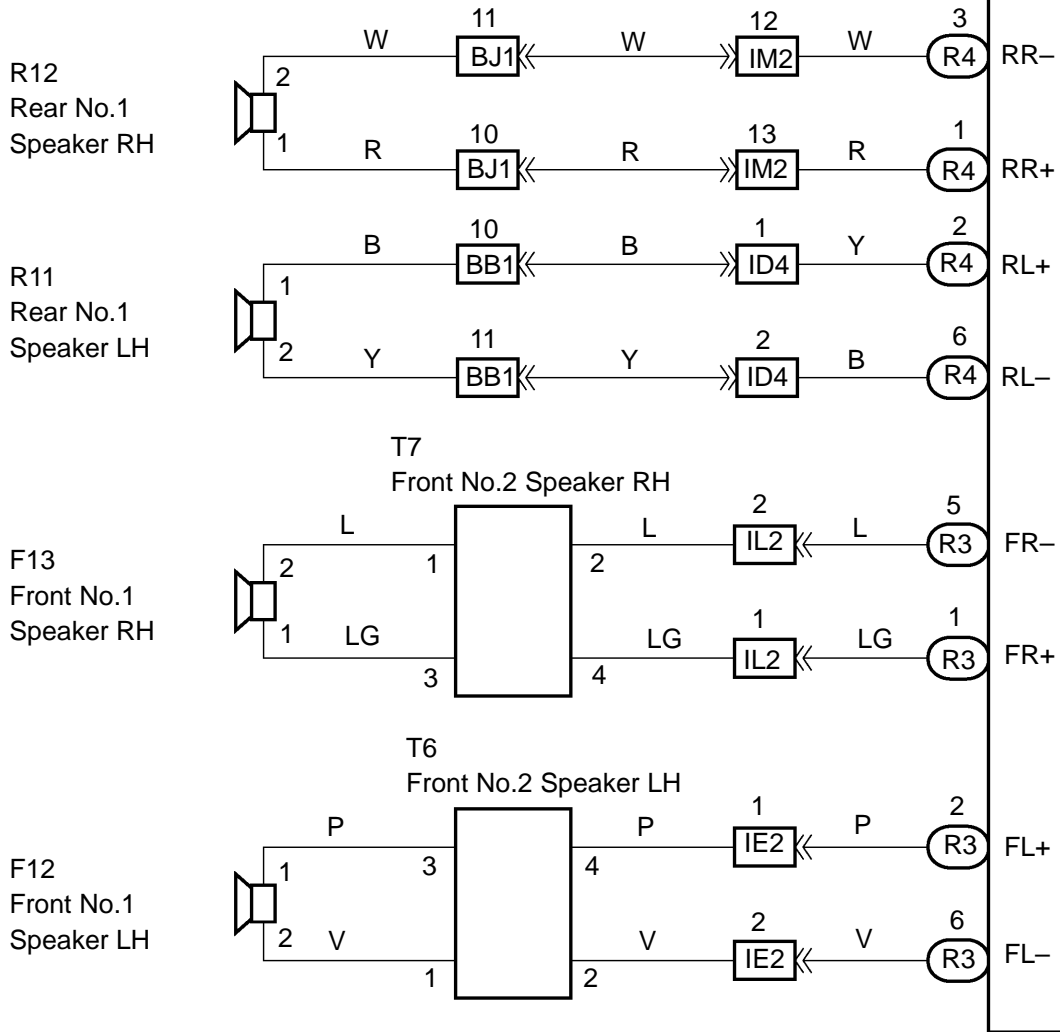
I39046

Built-in Type Amplifier:

Radio Receiver Assy

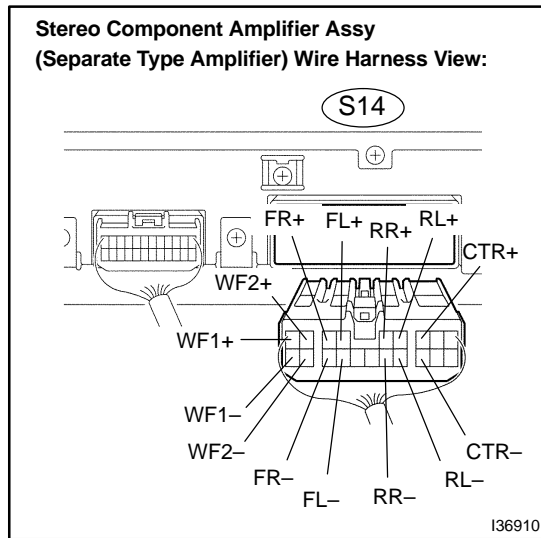
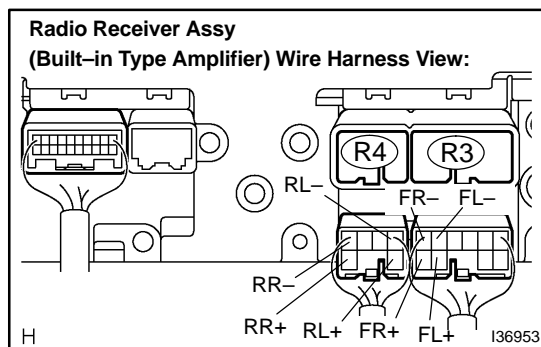
H I39338

1 CHECK HARNESS AND CONNECTOR

- (a) Disconnect the connectors shown in the illustration on the left from the stereo component amplifier assy and speakers.
- (b) Measure the resistance between the speaker and the stereo component amplifier assy or the radio receiver assy to check for an open circuit in the wire harness.

Standard:

Below 1 Ω

- (c) Measure the resistance between the speaker and body ground to check for a short circuit in the wire harness.

10 k Ω or higher

Center Speaker Assy (Wire Harness Side)
Connector Front View:

Front No.1 Speaker Assy (Wire Harness Side)
Connector Front View:

Front No.2 Speaker Assy (Wire Harness Side)
Connector Front View:

Rear No.1 Speaker Assy (Wire Harness Side)
Connector Front View:

Rear No.2 Speaker Assy (Wire Harness Side)
Connector Front View:

NG → REPAIR OR REPLACE HARNESS OR CONNECTOR
