<b>DTC</b>	<b>B1423</b>	<b>PRESSURE SWITCH CIRCUIT</b>
------------	--------------	--------------------------------

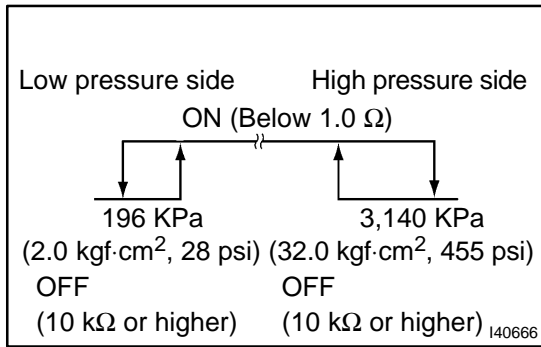
**CIRCUIT DESCRIPTION**

The pressure switch to detect the refrigerant pressure is located in the sight glass side of the pipe on the high-pressure side. This DTC is output when the refrigerant pressure is either significantly low (below 196 kPa (2.0 kgf/cm<sup>2</sup>, 28 psi) or significantly high (over 3,140 kPa (32.0 kgf/cm<sup>2</sup>, 455 psi)). Then the pressure switch sends appropriate signals to the A/C amplifier. The pressure switch has built-in switches to detect high and low pressure and is turned off when either is determined to be defective. The A/C amplifier continuously monitors the pressure switch signal after the power switch is turned on. It stops compressor control and output the DTC when it detects the signal indicating that the switch is turned off.

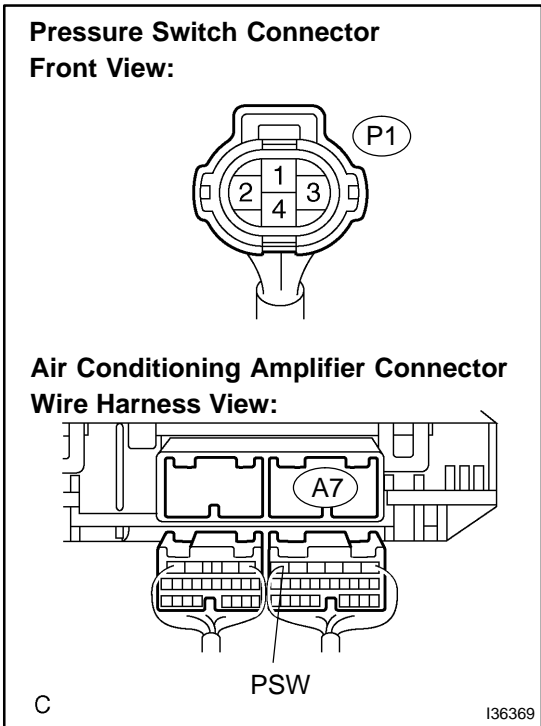
**3 CHECK HARNESS AND CONNECTOR(PRESSURE SWITCH – AIR CONDITIONING AMPLIFIER) (SEE PAGE 01-47)**

- (a) Disconnect the connector from pressure switch.
- (b) Measure the resistance according to the value(s) in the table below.

Tester connection	Condition	Specified condition
A7-6 (PSW) – P1-4	Always	Below 1 Ω
P1-1 – Body ground	Always	Below 1 Ω
A7-6 (PSW) – Body ground	Always	10 kΩ or higher
