DTC	P0A90/239	DRIVE MOTOR "A" PERFORMANCE
DTC	P0A90/241	DRIVE MOTOR "A" PERFORMANCE
DTC	P0A90/602	DRIVE MOTOR "A" PERFORMANCE

CIRCUIT DESCRIPTION

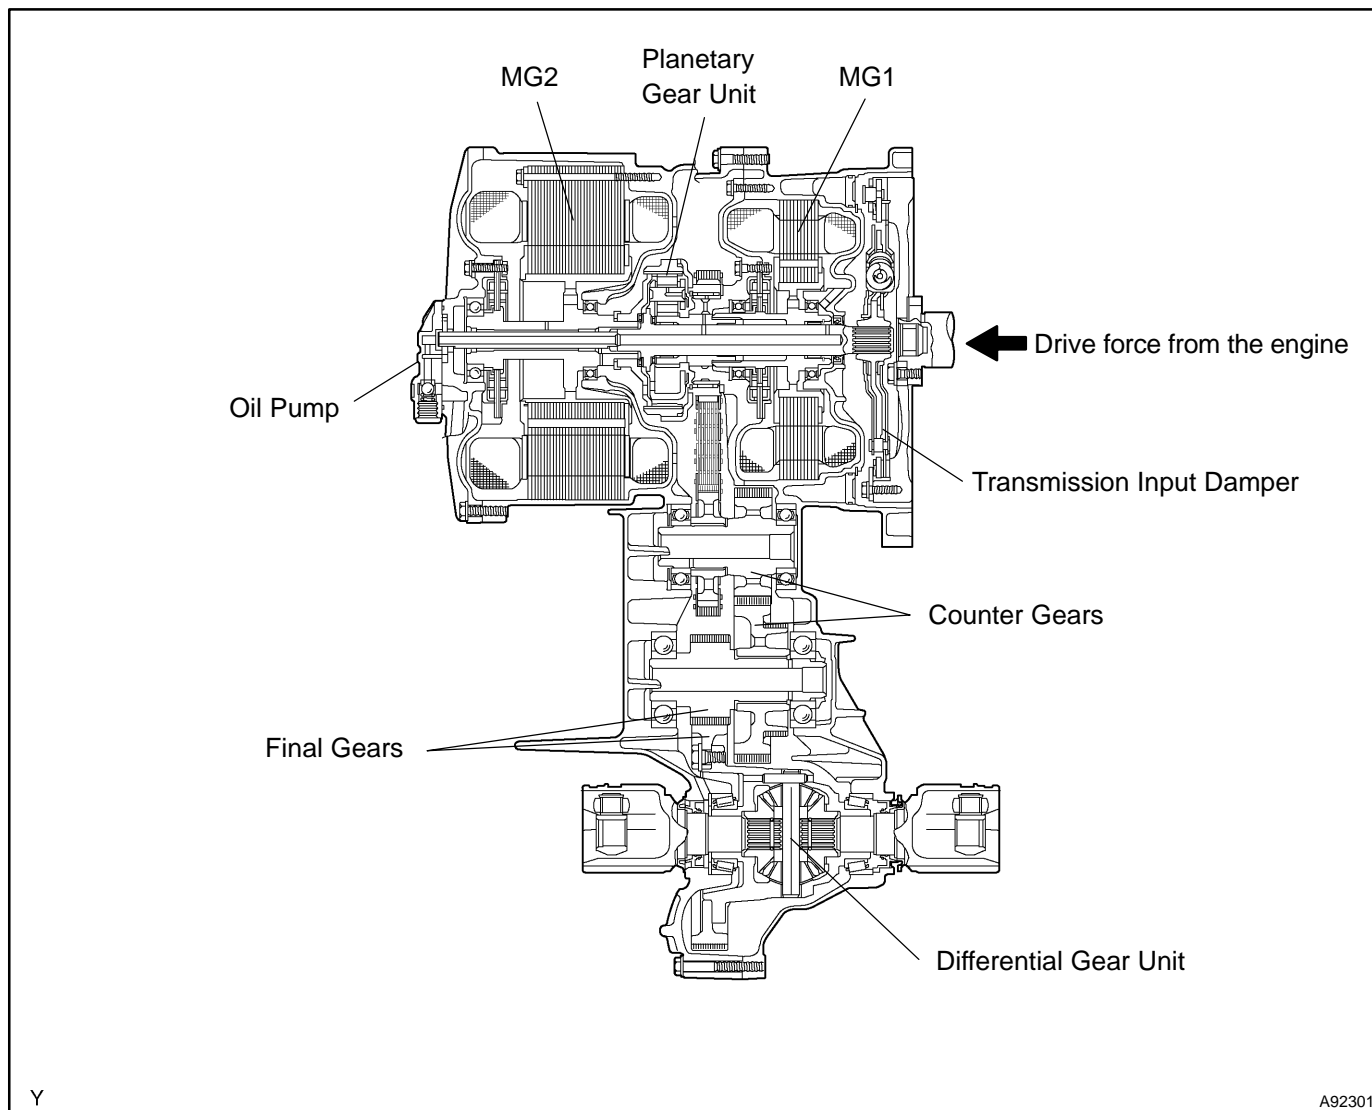
The HV transaxle consists of a planetary gear unit, MG1, and MG2.

A gear unit uses the planetary gear to split engine output in accordance with a driving request during driving the vehicle or charging its internal HV battery.

The MG2 provides assist to the engine output while increasing the drive force of the vehicle. Furthermore, the MG2 effects regenerative braking by converting the energy (which is consumed in the form of heat during normal braking) into electrical energy and recovering it into the HV battery. Through regenerative braking, as well as decelerating the vehicle, the MG2 generates high-voltage electrical power which is used for the purpose of charging the HV battery.

The MG1 supplies electrical power, which is used for charging the HV battery or for driving the MG2. It also has a stepless transmission function to control the transaxle by regulating the amount of generation of electrical energy, which effectively varies the MG1 speed. In addition, the MG1 is used as a starter motor to start the engine.

The transmission input damper absorbs the shock that accompanies transmission of the drive force from the engine.

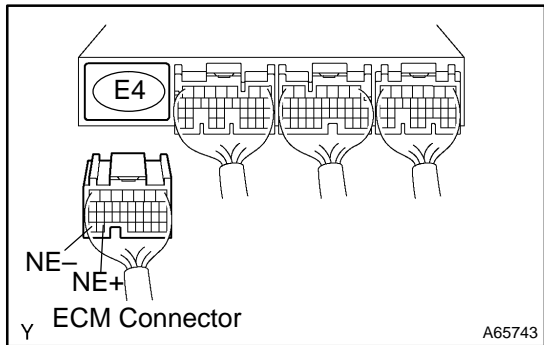
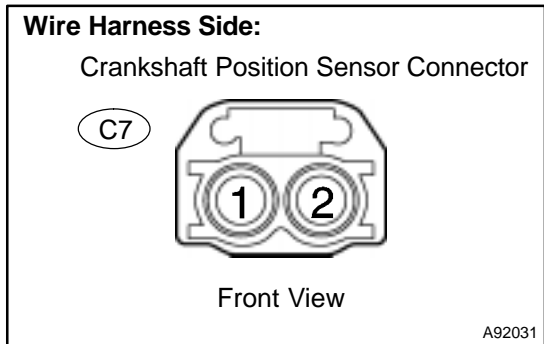
3 CHECK HARNESS AND CONNECTOR(ECM - CRANKSHAFT POSITION SENSOR)

- (a) Disconnect the E4 ECM connector.
- (b) Disconnect the C7 crankshaft position sensor connector.
- (c) Check the resistance between the wire harness side connectors.

Standard (Check for open):

Tester Connection	Specified Condition
NE+ (E4-33) - Crankshaft position sensor (C7-1)	Below 1 Ω
NE- (E4-34) - Crankshaft position sensor (C7-2)	Below 1 Ω

Standard (Check for short):

Tester Connection	Specified Condition
NE+ (E4-33) or Crankshaft position sensor (C7-1) - Body ground	10 kΩ or higher
NE- (E4-34) or Crankshaft position sensor (C7-2) - Body ground	10 kΩ or higher

- (d) Reconnect the crankshaft position sensor connector.
- (e) Reconnect the ECM connector.

NG → REPAIR OR REPLACE HARNESS OR CONNECTOR

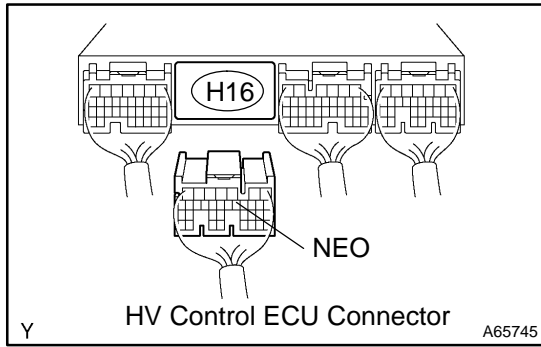
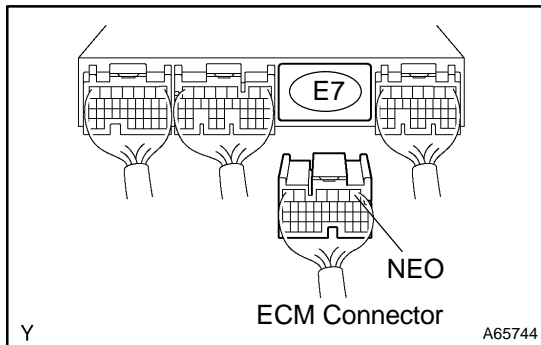
4 CHECK HARNESS AND CONNECTOR(HYBRID VEHICLE CONTROL ECU - ECM)

- (a) Disconnect the H16 HV control ECU connector.
- (b) Disconnect the E7 ECM connector.
- (c) Check the resistance between the wire harness side connectors.

Standard (Check for open):

Tester Connection	Specified Condition
NEO (H16-12) - NEO (E7-1)	Below 1 Ω

Standard (Check for short):

Tester Connection	Specified Condition
NEO (H16-12) or NEO (E7-1) -Body ground	10 kΩ or higher

- (d) Reconnect the ECM connector.
- (e) Reconnect the HV control ECU connector.

NG REPAIR OR REPLACE HARNESS OR CONNECTOR
