ROUTE CANNOT BE CALCULATED

INSPECTION PROCEDURE

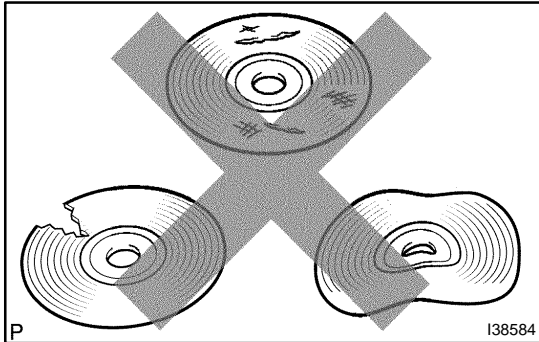
1 CHECK THE MAP DISC

- (a) Check that the map disc is not deformed or cracked.
OK: No deformations or cracks appear on the map disc.

REPLACE THE MAP DISC
