AUTO UP OPERATION DOES NOT FULLY CLOSE POWER WINDOW (JAM PROTECTION FUNCTION IS ACTIVATED)

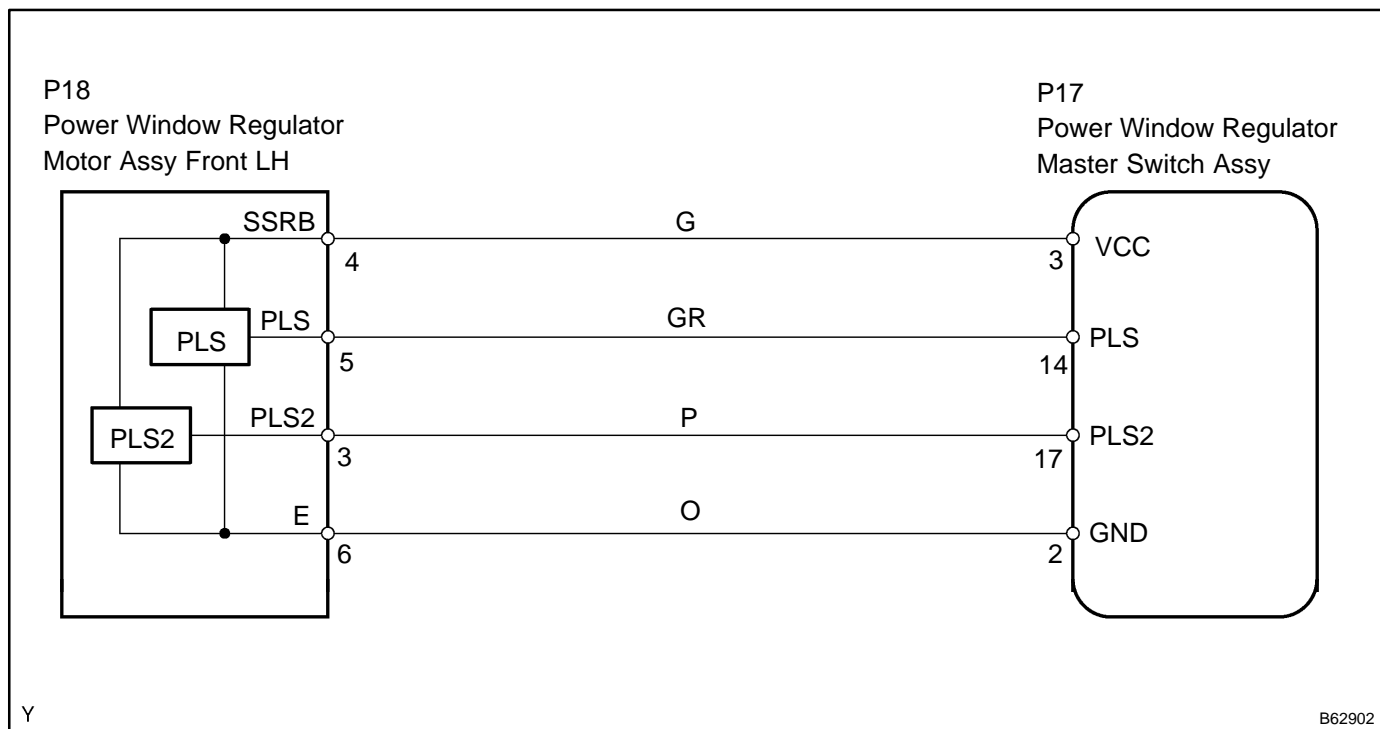
WIRING DIAGRAM

If the door glass or the power window regulator motor does not operate smoothly, the jam protection function may trigger automatically, resulting in the AUTO UP function being unable to fully close the window.

The jam protection function is only available on the driver side power window.
