# AIR CONDITIONING AMPLIFIER ASSY REPLACEMENT

55190-01

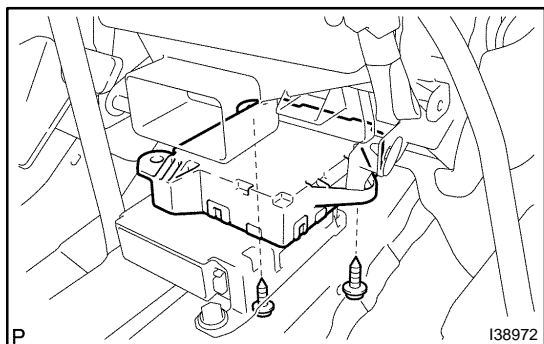
3. REMOVE AIR CONDITIONING AMPLIFIER ASSY
  - (a) Disconnect the connector.
  - (b) Remove the 2 screws and then the air conditioning amplifier assy.
