TORQUE CONVERTER AND DRIVE PLATE

INSPECTION

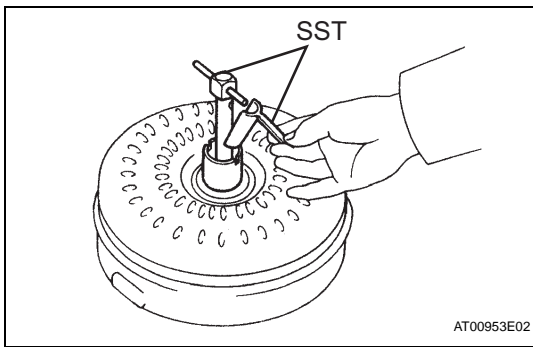
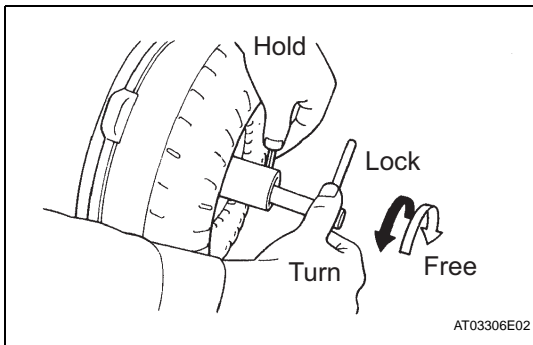
- (a) Inspect the one-way clutch.
- (1) Install SST to the inner race of the one-way clutch.
SST 09350-32014 (09351-32010)
 - (2) Set SST so that it fits in the notch of the converter hub and in the outer race of the one-way clutch.
SST 09350-32014 (09351-32020)
 - (3) With the torque converter standing on its side, check that the clutch locks when SST is turned counterclockwise and rotates freely and smoothly when turned clockwise. If the results are not as specified, clean the converter and recheck the one-way clutch. If the results still are not as specified, replace the converter.

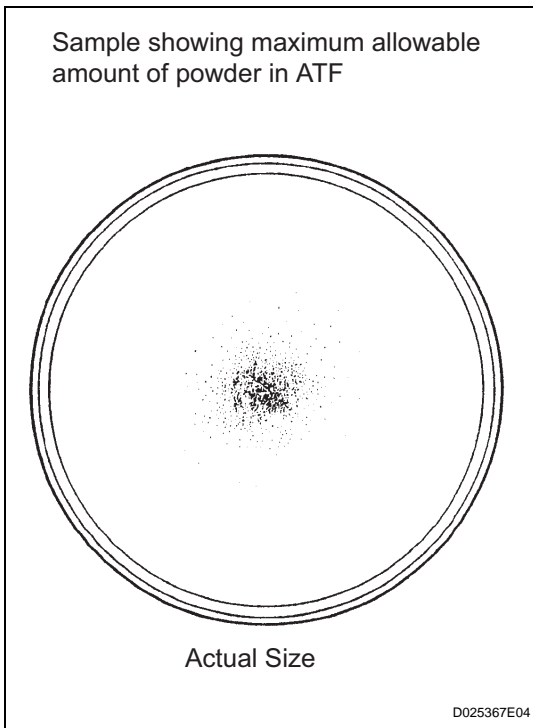
- (b) Determine the condition of the torque converter clutch.
 - (1) Check that the following conditions are met:
 - During the stall test or when the shift lever is on N, metallic sounds are not emitted from the torque converter clutch.
 - The one-way clutch turns in one direction and locks in the other direction.
 - The amount of powder in the ATF is not greater than the sample shown in the illustration.
If the results are not as specified, replace the torque converter clutch assembly.

HINT:
The sample illustration shows approximately 0.25 liters (0.26 US qts, 0.22 Imp. qts) of the ATF taken from a removed torque converter clutch.
- (c) Replace the ATF in the torque converter clutch.
 - (1) If the ATF is discolored and/or has a foul odor, stir the ATF in the torque converter clutch thoroughly and drain the ATF with the torque converter facing upward.

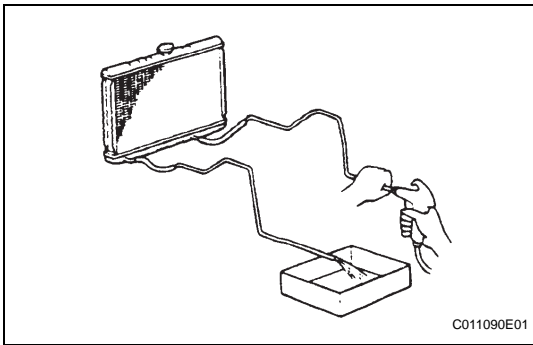
- (d) Clean and check the oil cooler and oil pipe line.
 - (1) If the torque converter clutch is inspected or the ATF is replaced, clean the oil cooler and oil pipe line.
 - Apply compressed air of 196 kPa (2 kgf/cm², 28 psi) into the inlet hose.
 - If a large amount of powder is found in the ATF, add new ATF using a bucket pump and clean the oil cooler and oil pipe line again.
 - (2) If the ATF is cloudy, inspect the oil cooler (radiator).

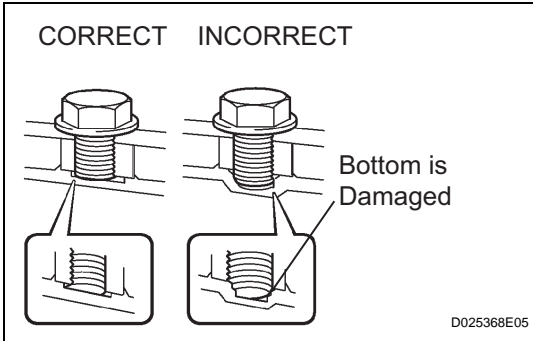
- (e) Prevent deformation of the torque converter clutch and damage to the oil pump gear.
 - (1) When any marks due to interference are found on the end of the bolt for the torque converter clutch and on the bottom of the bolt hole, replace the bolt and torque converter clutch.
 - (2) All of the bolts should be the same length.
 - (3) Make sure no spring washers are missing.

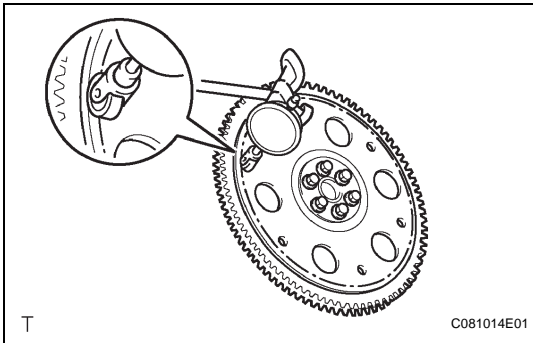
- (a) Set up a dial indicator and measure the drive plate runout.
 - Maximum runout:**
0.30 mm (0.0118 in.)
 - If the runout is greater than the maximum or if the ring gear is damaged, replace the drive plate. If installing a new drive plate, be careful of the orientation of the spacers and tighten the bolts.
 - Torque: 98 N*m (999 kgf*cm, 72 ft.*lbf)**
- (b) Check the ring gear for any damage.
 - If the ring gear is damaged, replace the drive plate.
