TORQUE CONVERTER AND DRIVE PLATE

INSPECTION

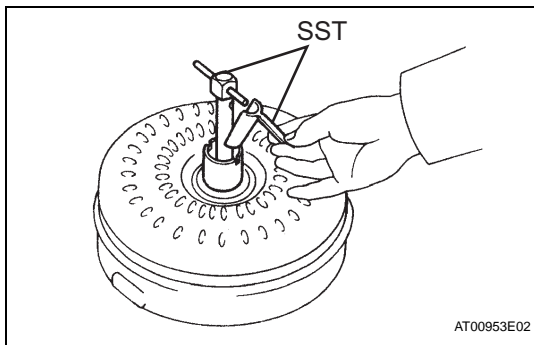
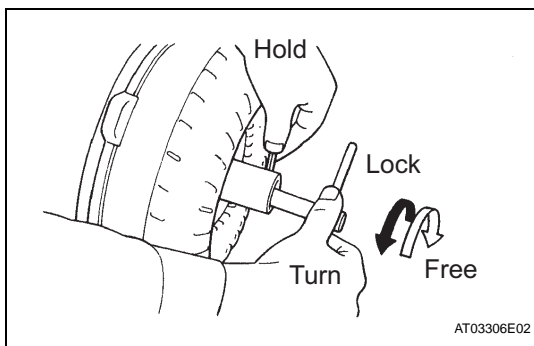
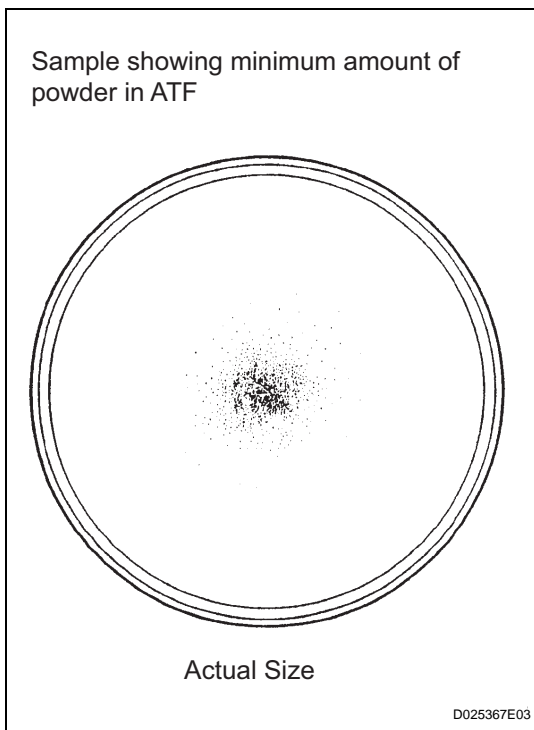
- (a) Inspect the one-way clutch.
- (1) Install SST to the inner race of the one-way clutch.
SST 09350-32014 (09351-32010)
 - (2) Set SST so that it fits in the notch of the converter hub and in the outer race of the one-way clutch.
SST 09350-32014 (09351-32020)
 - (3) With the torque converter standing on its side, check that the clutch locks when SST is turned counterclockwise and rotates freely and smoothly when turned clockwise. If the results are not as specified, clean the converter and recheck the one-way clutch. If the results still are not as specified, replace the converter.

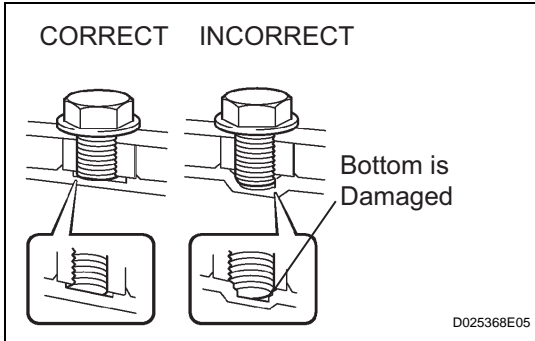
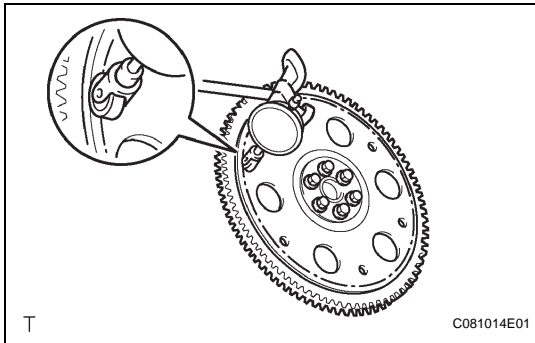
- (d) Clean and check the oil cooler and oil pipe line.
- (1) If the torque converter clutch is inspected or the ATF is replaced, clean the oil cooler and oil pipe line.
 - Apply compressed air of 196 kPa (2 kgf/cm², 28 psi) into the inlet hose.
 - If a large amount of powder is found in the ATF, add new ATF using a bucket pump and clean the oil cooler and oil pipe line again.
 - (2) If the ATF is cloudy, inspect the oil cooler (radiator).
- (e) Prevent deformation of the torque converter clutch and damage to the oil pump gear.
- (1) When any marks due to interference are found on the end of the bolt for the torque converter clutch and on the bottom of the bolt hole, replace the bolt and torque converter clutch.
 - (2) All of the bolts should be the same length.
 - (3) Make sure no spring washers are missing.
